Electrical Safety Audit in a Healthcare Unit

L. Ramesh, M. Madhusudhana Raju, Vijayakumar Mani

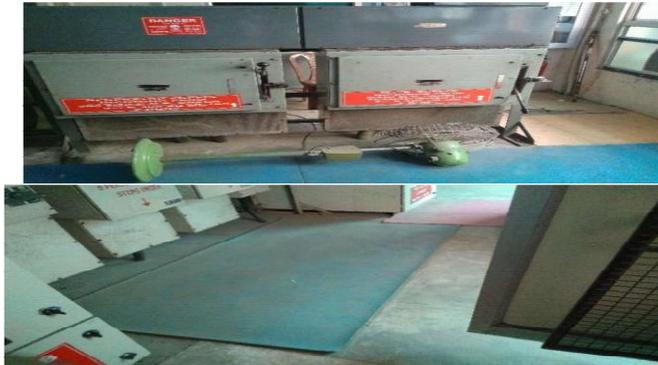
Case 1: Observation: Heating of terminals are identified. Old switchgear is present with very less ground clearance. Fans are used to cool the breaker terminals. Recommendation: Switchgears should be replaced with new one with proper ground clearance. Case 2: Observation: Rubber mat are not as per standard. Recommendation: Proper Rubber mat should be provided as per IS 15652.

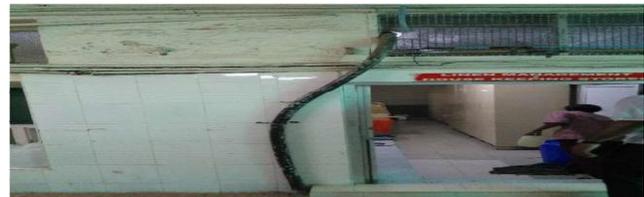
Case-1

Case 1: Observation: Auxiliary transformer for mechanical box is opened and no protection is carried out. Recommendation: Auxiliary transformer for mechanical box should be properly closed. Case 2: Observation: In proper Cable Entry. Recommendation: Cable Entry should be done at underground only.

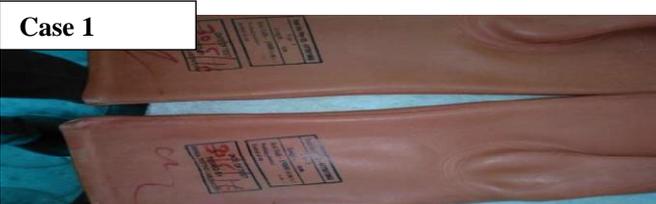
Case 1

Case 1: Observation: Rubber glouse testing expired. Recommendation: As IEC60903, rubber glouse should be tested for every 6 months. Case 2:
 Observation: Copper Flat track is missing. Recommendation: Copper Flat shall be layed to achieve proper grounding.

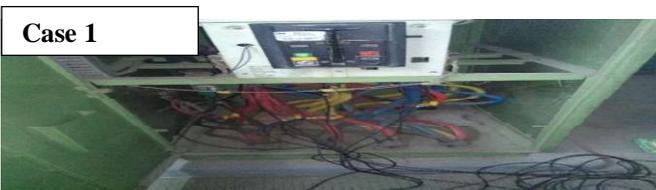
Case 1

Case 1: Observation: Generator power quality testing carried out. Supporting results in Power Quality Study. Recommendation: Results attached in
 PQA study. Case 2: Observation: Proper Earth mat is missing. Recommendation: Earth mat should be provided.

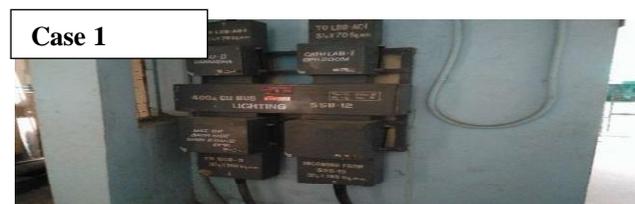
Case 1

Case 1: Observation: Proper Name plate & addressing of the panel is missing. Recommendation: It should be provided with Electrical Name plate
 Stickers. Case 2: Observation: Gland Earthing is not present. Recommendation: Gland earthing should be provided.

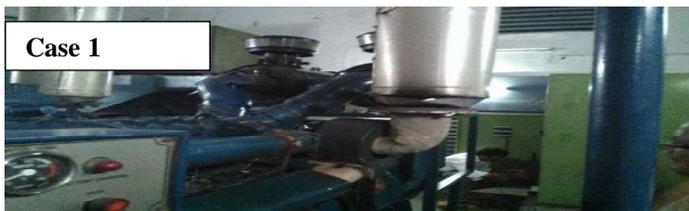
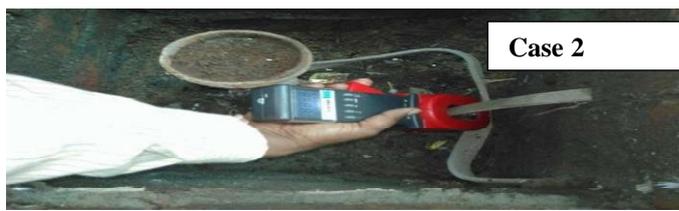
Case 1: Observation: Found Smoke Exhaust damaged. Recommendation: Smoke exhaust should be rectified.
Case 2: Observation: Earth Pit Clearance for regular checking is inadequate. Recommendation: Earth Pit Clearance for regular checking is required.

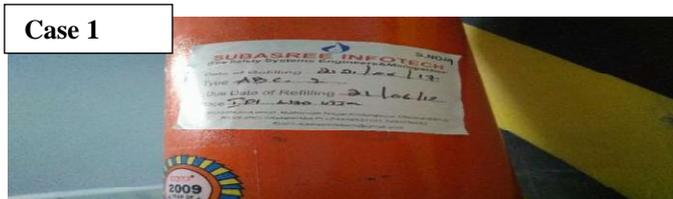
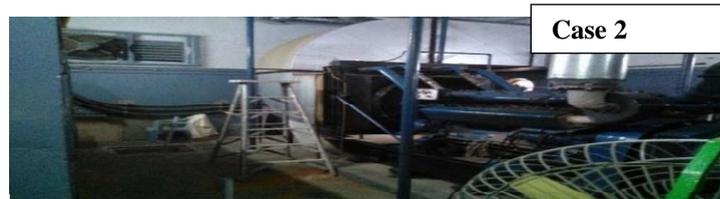
Case 1: Observation: Calibration is date expired. Recommendation: Fire Extinguisher should be inspected for regular calibration.
Case 2: Observation: Fire Extinguisher is not available. Recommendation: Fire Extinguisher should be provided.

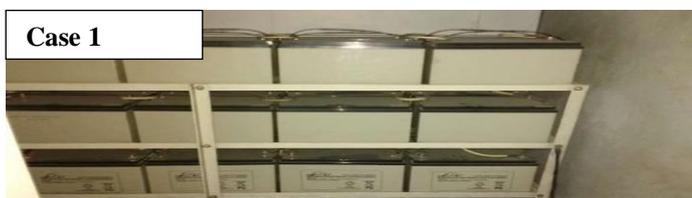
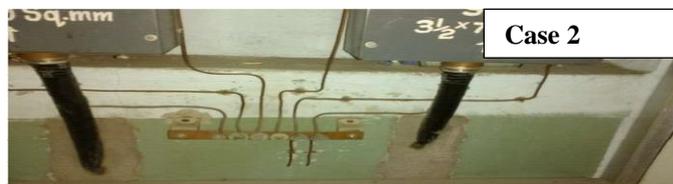
Case 1: Observation: Battery terminals were easily accessible and rubber mat is not provided. Recommendation: Battery should be enclosed and rubber mat should be provided. Case 2: Observation: Cable & earthing leads are concreted. Recommendation: Cable & earthing leads should be free from concrete materials.

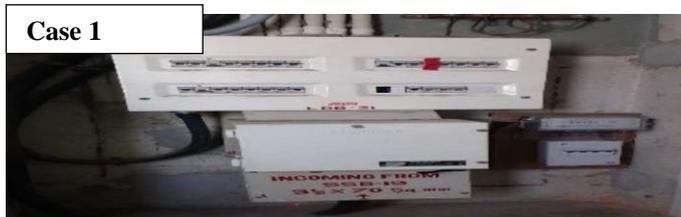
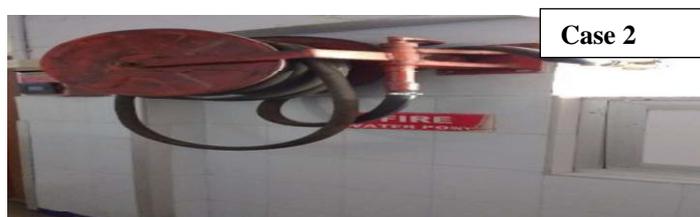
Case 1: Observation: Red Taped overloaded MCB is identified. Recommendation: MCB Should be rated as per the Load design condition. Case 2: Observation: Proper maintenance required for Fire Fighting System. Recommendation: Fire Fighting system should be properly maintained with nozzle holder.

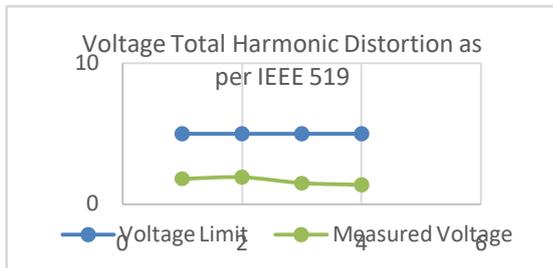
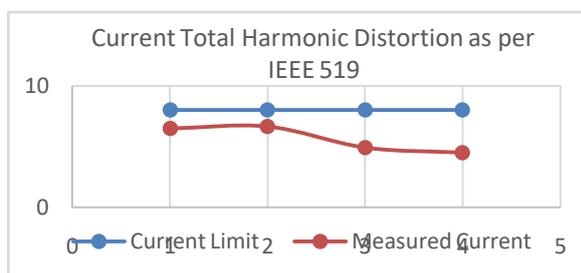
As per IEEE 519 the ITHD - Total Current Harmonics Distorsion should be less than 8% & VTHD - Total Voltage Harmonics distorsion should be less than 5% and the above measured values is within the limits. As per the observation measured the power factor in all the incomers are maintained above 0.95. Voltage fluctuations are within the limit with Unbalanced condition presents in all the incomers. Strictly advised to Split the loads evenly in all incomers to reduce the unbalanced condition and neutral current.
