Defect Analysis on Boeing 737-400 Skin Panel Rivet Row Aft Ward Fuselage

Index Terms: Non-destructive Testing (NDT), defect analysis, skin panel rivet, Boeing 737-400

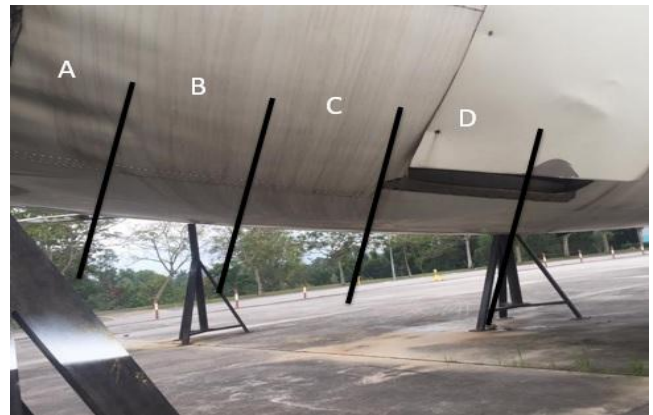
Fig. 7 Inspection Zones

The body station at the Boeing 737 from BS 747 to BS 967 has been divided to 4 Zone which is Zone A, Zone B, Zone C and Zone D. The Zone was divided to 4 section with 10 rivet panel on each Zone. This Zone was developed for research purpose as evidence showed in Figure 7.

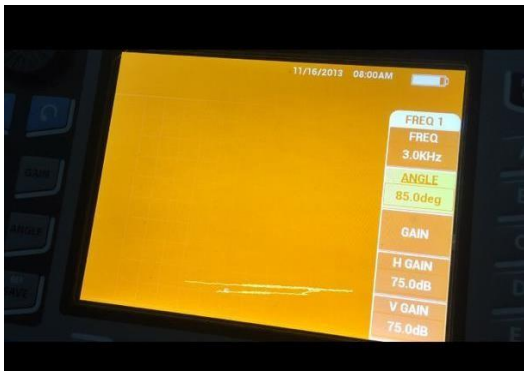
Fig. 11 10% of material loss

The result for the material loss test is gain and the data was referred to the Olympus Standard reference. The line if it cross to one grid is considered that the sub surface has 10% of material loss – as indicated in Figure 11. Line that cross on three grids is considered the sub surface has 20% material loss as shown in Figure 12. For line that across on four grids is considered that the sub surface has 30% of material loss as evidence in Figure 13.

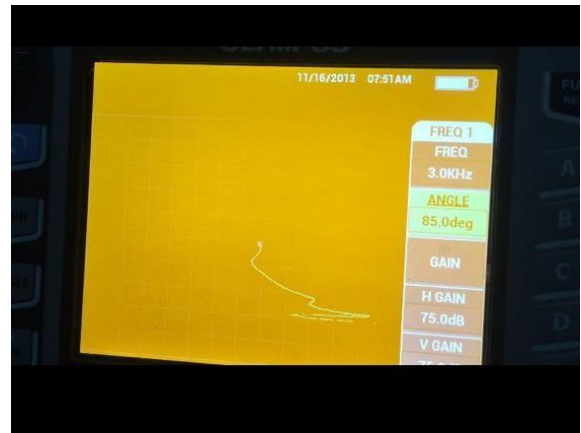
Fig. 14 0.0598 inch of crack

The result for crack test is gain and the data was referred to the Olympus Standard reference. The line if it cross on one grid is considered that the sub surface has 0.0598-inch crack – as indicated in Figure 14. Line that cross on three grids is considered the sub surface has 0.1601 inch as shown in Figure 15. For line that across on four grids or more is considered that the sub surface has 0.2004 inch of crack or more as evidence in Figure 16.

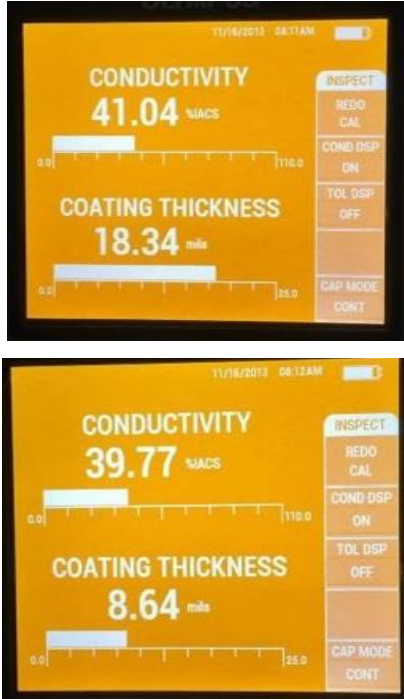
Fig. 17 – Comparisons of Conductivity Test Results

The result for conductivity test is gain and the data was referred to the Olympus Standard reference using alloy 7075 Temper (0). The percentage shows the conductivity gain at the subsurface that in contact with the probe. The conductivity percentage is then converted to hardness as per Figure 18. If the value is below the limitation the subsurface is affected by deformation whereas if the value exceeds the limitation it is affected by brittleness.

Figure 17 shows the comparison of the results for the conductivity test at the fuselage BS 747 to BS 967.

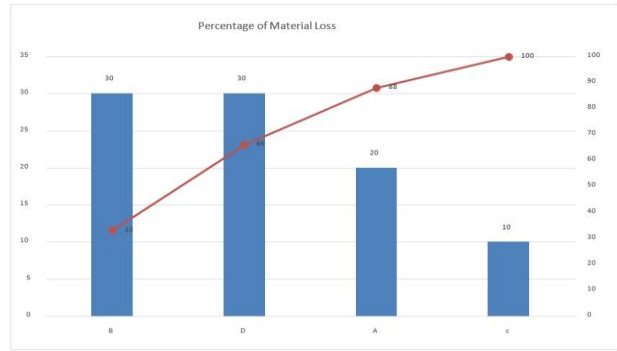
Fig. 19 – Percentage of Material Loss Analysis

The graph from Figure 19 below shows that 80% of the material loss comes from Zone B, Zone D and Zone A. These Zones are the most affected area from material loss due to exposure to the outside high temperature and humidity. Thus, these area needs further investigation and possible repair.

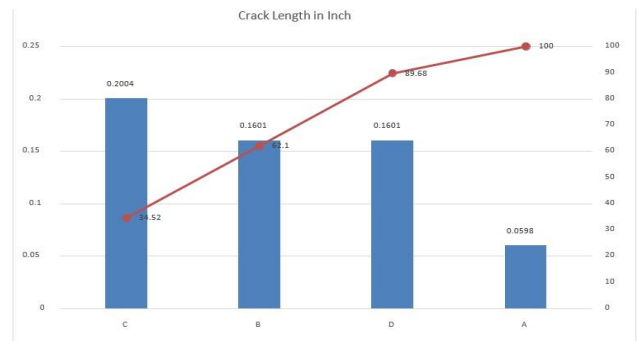
Fig. 20 – Crack Analysis

The graph from Figure 20 below shows that 80% of the crack comes from Zone c, Zone B and Zone D. These Zones are the most affected area from cracks base on the inspection carried out. Hence, it is essential for further investigation and possible repair to avoid these fatigue crack elongates and danger another area of the fuselage.

Second objective is to conduct crack inspection on Boeing 737-400 skin panel rivet row aft ward fuselage and the results say that the test result as prove in Pareto Chart for Crack (4.4.3) shows that Zone C, Zone B and Zone D need to be repaired as crack from that area can elongate and endanger undamaged area to crack.

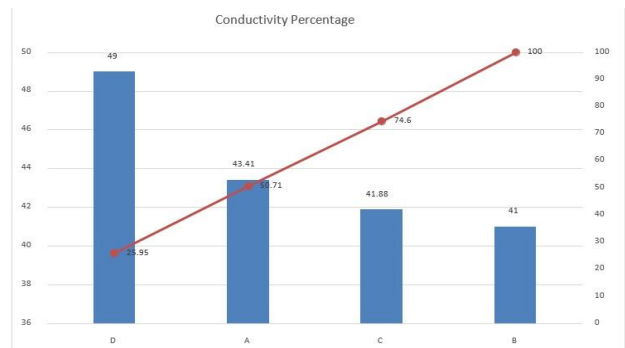
Fig. 21 – Conductivity Test Analysis

The graph from Figure 21 below shows that 80% of the subsurface that expose deformation and brittleness comes from Zone D, Zone A and Zone C. These Zones are the most affected area from deformation and brittleness as the Zones are not within the limitation range for alloy 7075 Temper (0) which is from 44% to 48%. If the value is below the limitation the subsurface is affected by deformation whereas if the value exceeds the limitation it is affected by brittleness.
