# Kinematic Analysis of the Dam and Powerhouse Sites of the Baglihar Hydropower Project

Romesh Kumar, G. M. Bhat, Yudhbir Singh, Arjun Singh, Ahsan Ul Haq

**Key words:** Baglihar Dam, RMRb, SMR, Kinematic Analysis.

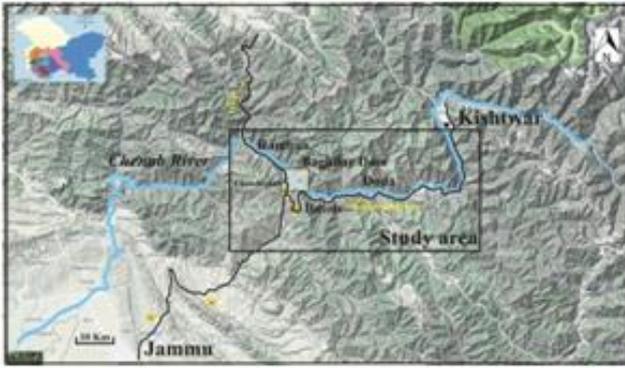
The area experience annual average rainfall of 1209 mm with tropical to temperate climatic conditions having average temperature of 21.1° C. The sites are located in deep gorge (Fig.2d) with rugged terrain having steep slopes (ranging from 45°- 70°). The study area comprises of quartzites, slates and phyllites having general trend of ENE-WSW with dip of 65-70° towards SSW.

**Fig.2: Representative Field photographs at and downstream of the dam site.**

(S1, S3 and S12) are completely unstable (Class-V), and one site (S11) is partially stable (Class-III). The kinematic analysis reveals that at each site, joint intersects with each other on slope and form potential failure sites where nine sites (S1, S2, S4, S5, S6, S7, S8, S11, S12) are susceptible to wedge failure (Fig. 2c), six sites (S4, S6, S7, S8, S9, S10) are susceptible to topple failure, and two sites (S3 and S12) are likely to plane failure (Fig. 2a) and percentage of category-wise failure sites are shown in Figure 6. The rock slope failure occurring in the fair rock category may be assigned to mechanical excavation activity along the road leading to the dam site, although the contribution from highly jointed rocks (Fig.2b) due to tectonic activity cannot be ruled out.

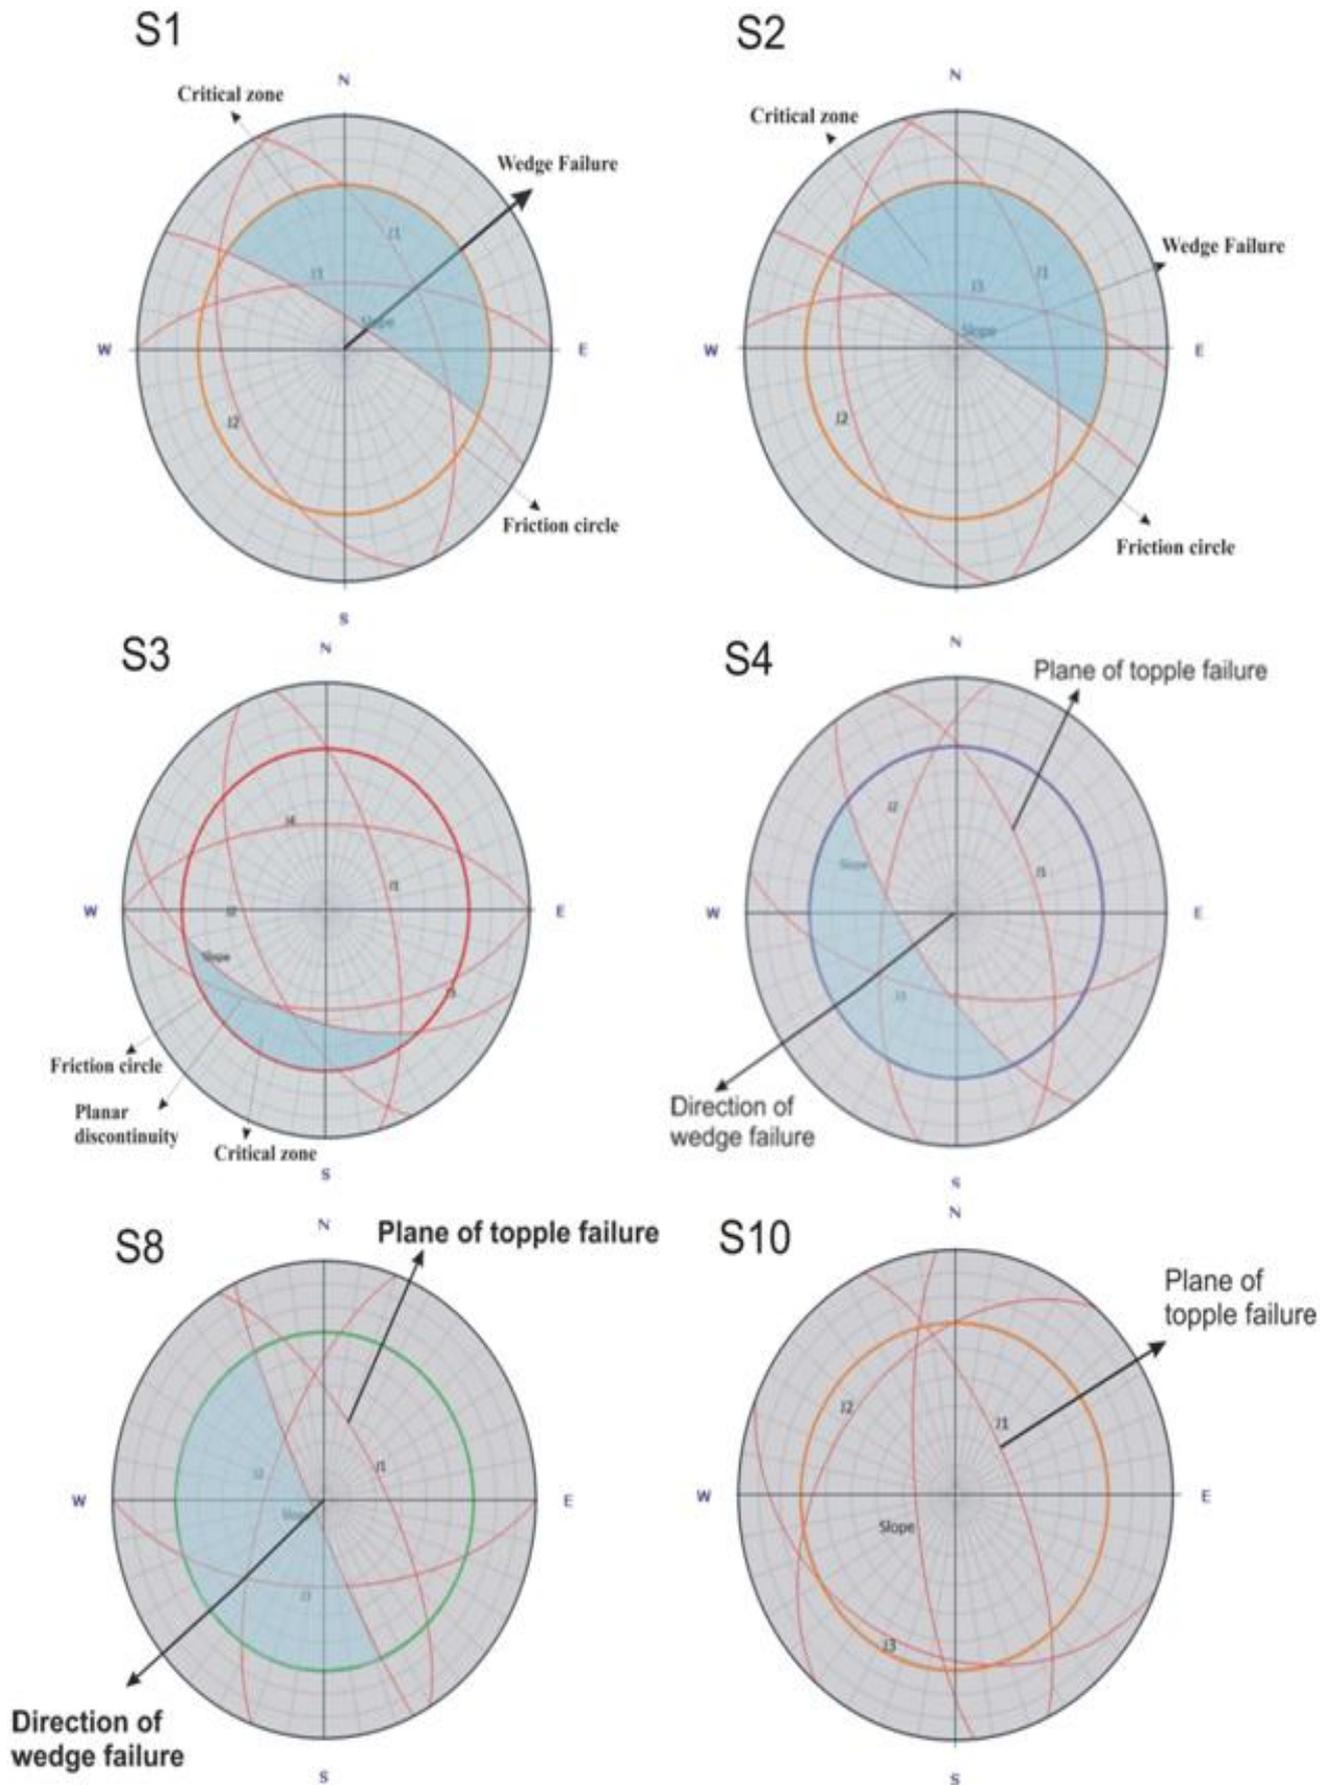
The joint walls have an aperture ranging from 0-12 mm. The calculated RMR value for this site is 50 that falls under fair rock quality. Kinematic analysis of discontinuity planes and their intersections (Fig. 4) with respect to slope face indicates that there is possibility of wedge failure by the intersection of joint planes  $62^{\circ}/N80^{\circ}W$  (J2) and  $61^{\circ}/S10^{\circ}W$  (J3) and toppling failure along Joint plane  $58^{\circ}/N70^{\circ}E$  (J1). The SMR value calculated from the potential failure of planes is 1 and 40. The average value of SMR for the site is 20.5. According to SMR Classification the rock mass of the site is bad and in unstable condition The site falls in Class IV and the probability of failure is 60%.

calculated RMR value for this site is 45 that falls under fair rock quality. Kinematic analysis of discontinuity planes and their intersections (Fig. 4) with respect to slope face indicates that there is possibility of topple failure along joint plane  $68^{\circ}/N65^{\circ}E$  (J1). The SMR value calculated from the potential failure of planes is 36.5. The rock mass of the site is in bad condition and unstable and falls in Class IV with probability of failure of 60%.

Fig.4: Stereographic projection plots of few unstable and completely unstable classes in the study area.

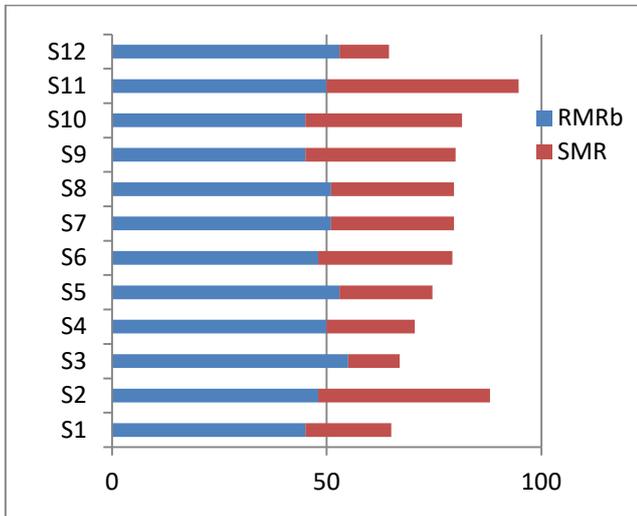
**Fig.5: The diagram showing comparison between observed RMR and SMR values of different sites in study area.**

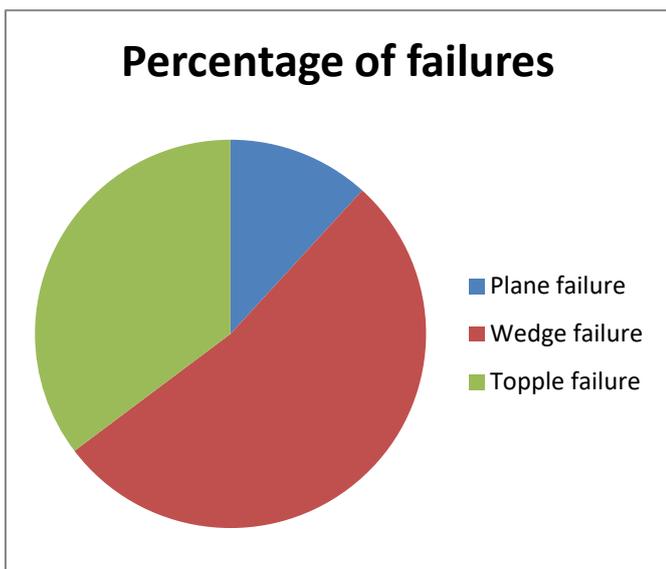
**Fig.6: The given chart showing percentage of different failure in the study area.**
