Structural Audit of Sadhu Vaswani Pul using Institutionally Developed Displacement Sensors.

Abstract— *The main aim of this study is to conduct the structural audit of the Sadhu Vaswani Pul which is a Rail Over Bridge, situated in Koregaon Park, Pune and to establish the displacement sensors developed in the institution as a reliable test for structural auditing of the bridge decks. Traditional methods of auditing like the Rebound Hammer test and the Ultrasonic pulse velocity tests have been considered in this study. Very few methods are available for testing the deck displacement and this problem has been tackled here. The novelty of this research is that the institutionally developed displacement sensors are used for determining the deck displacement of the selected bridge. These sensors have not been used before and no on-site techniques are available to obtain the deck deflections under real-time loading. The displacement test on the decks was conducted. The critical decks which were determined during the Visual Inspections were tested by the displacement sensors. A two-axle truck of 18.5 tonnes was passed over the bridge deck and the displacement readings were recorded at the

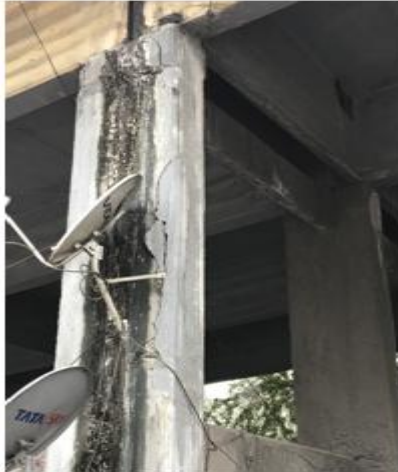
Figure 1:- Cracks in column number 6A due to satellite dishes.

This is due to non-uniformity in the material used during construction or the fact that proper construction practices might have not been implemented. Also, human settlements were seen below the bridge on the West side and since the columns of the bridge were used as supporting structures for the roofs built, the additional eccentric load was imposed on the columns. At several places, dish antennas were installed on the columns by drilling the antennas inside the column

without taking into account the reinforcement damage and thus further loss of strength of the column can be noted.

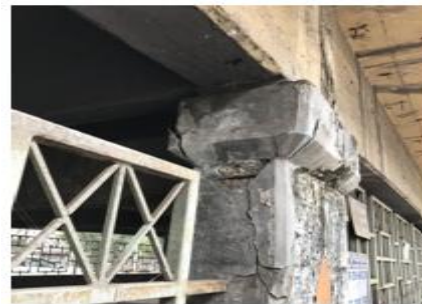
[4] After Visual Inspection, many severe horizontal and vertical cracks were seen on the selected bridge and thus critical sections were selected for further non-destructive testing purposes. The following are the critical sections selected.

Figure 3. Structural cracks were seen on the columns

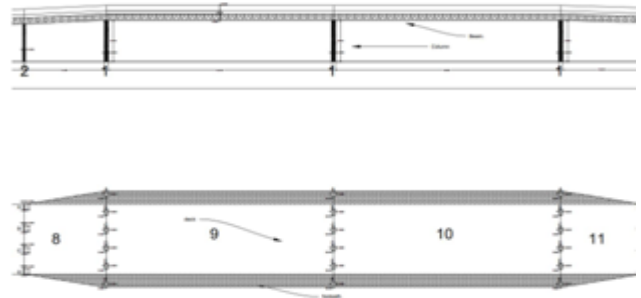
Figure 8. Central portion of the bridge with longest span deck.

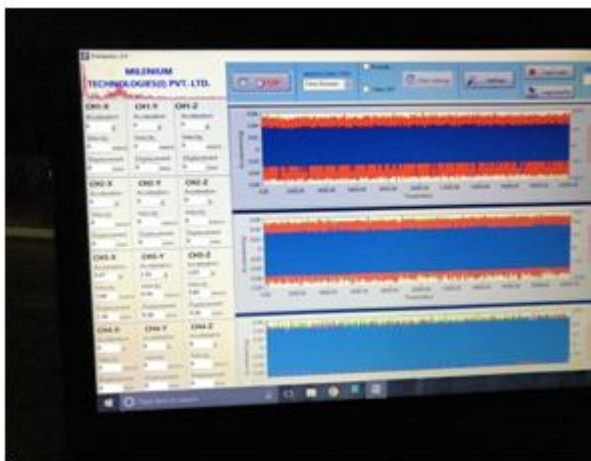
Thus from the above Table number VII, it is clear that the maximum value of displacement is 37.33mm or 0.12 feet. Since this value and all the other values of displacement in the Y direction are way less than the expected limit according to AASTHO-IFRD, it can be concluded that the decks are safe. The bridge was 25 years old and thus the minimum deflections suggest that the severe damages to the decks have not occurred. The bridge did not have any bearings present below the decks and the vibrations felt can be a result from the absence of bearings. Thus proper deck treatment or replacement and installation of bearings should be conducted to avoid further damage. The vibrations might lead to an increase in spacing between the expansion joints, causing an improper transfer of load to the columns, seepage of water to the internal portions leading to corrosion and thus causing serious problems which will be economically challenging and time-consuming. The positive results obtained from the test help to establish the fact that this method can be used on the site for deck displacements. Thus this method can be used for auditing the bridge decks or the other components of the bridge where the deflections or displacements occur. The compressive strength of the selected columns is mentioned in the Table number VIII and Table number IX. These indices are the average of the six readings taken beforehand. From the Rebound number vs Compressive strength graph, the compressive strengths of the columns are found and tabulated. The column Number 1 on the East side is the column with the maximum height of 6meters.

FIGURE 11 . DISPLACEMENT READINGS FOR DECK NUMBER 7.
