Assessment of Flood Hazard and its Effects in Dolokhat village of Lakhimpur District, Assam

Azruddin Khan, Manash Jyoti Bhuyan, Debashree Borah

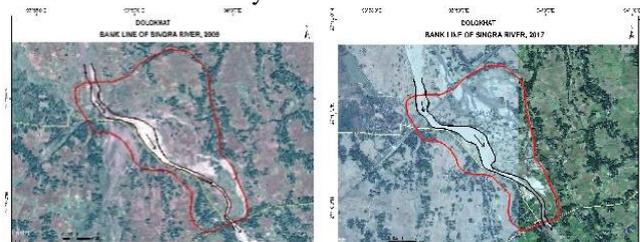
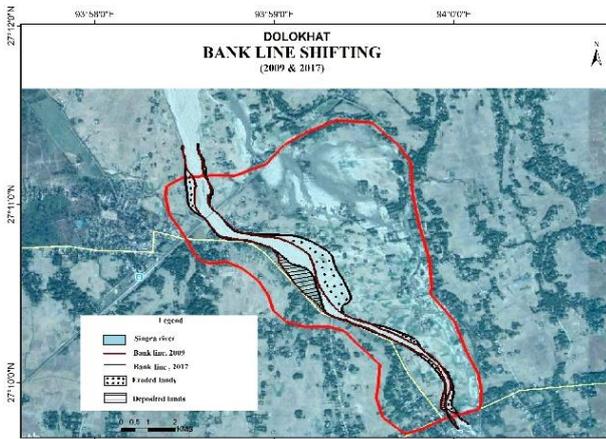
Fig. 4: Bank line shifting (2009-2017)

Noteworthy that, the river has been shifting its course towards the east due to which erosion has been a very common phenomenon.

Similarly, channel change over spatial and temporal dimension is accompanied by both vertical and horizontal movement of the channel. As such, Singri river is too related to horizontal expansion causing bank line migration, bank widening, cut-off, etc. (Table 1). A comparative assessment of bank lines is prepared based on differential periods from 2005-2017 (Fig. 4). During the year 2005, the rate of erosion was 8.12 while deposition as 5.76 that was minimal with lesser destruction (table). In 2009, rate of erosion (14.08%) accelerated than deposition (5.32) while the massive flooding occurred during 2018 with 22.60% area under erosion drowning number of villages, croplands, properties, human lives, etc. The chronically flood-affected areas of Dolokhat village have been shown in Fig. 5. Pre-monsoonal shower causes the river to overflow at Naoboicha and due to breaching of the embankment; heavy losses were witnessed by the dwellers.

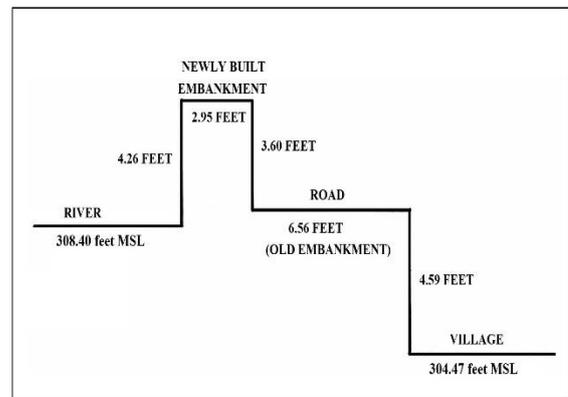
Fig. 6: A schematic diagram showing the differential altitudinal positions of the riverbed, newly constructed embankment, road, and the village.

As such due to heavy downpour in the upper catchment areas of the river Singra, the Dolokhat village and its surrounding areas are acutely inundated. The river Singra entering the plains from the foothills causes floods in the plains as the immediate downstream areas are also having similar elevations. Therefore, excess river water does not flow immediately and takes time to flow downstream. Hence, the river water overflows its banks thereby causing floods. However, it is interesting to note that the riverbed is located at an elevation of about 94 m, while the village is located at an elevation of about 92.80 m. Thus, the village is located 1.10 m lower than the riverbed (Fig. 6). Noteworthy that the newly built embankment was constructed with sands (Fig. 7), therefore it is easily breached by the river water during the peak monsoon season. Sandy soils are more prone to erosion from rainwater and runoff (Thorne and Tovey, 1981) because they are loose and thus are eroded easily. Again, as water always flows from the higher altitudinal to lower altitudinal areas, the river water then flows over the old embankment, which acts as the road, and finally, the river water enters the village causing severe problems to the people.

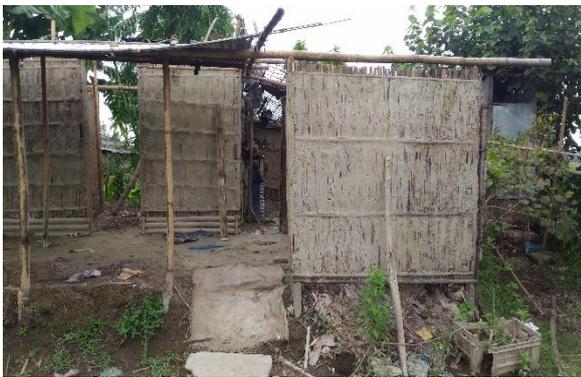
Fig. 8: An abandoned house in the village

The people in the villages of the Brahmaputra valley have long been facing a large number of problems caused by the floods and thus, adapt themselves accordingly with the flooding situation (Nayak and Panda, 2016). People belonging to different castes and communities have their own ways of coping up with the flooding environment. Similarly, the Dolokhat village has been undergoing severe problems because of the recurrent floods. The floods of the Singra river has eroded the agricultural lands of many people due to which they had to engage themselves as daily wage workers. Thus, agricultural production in the village has been affected by floods. It should be mentioned here that during 2018, 4.23 hectares of land has been eroded during floods. Besides, destruction of roads, houses, and other infrastructures, loss of property and domesticated animals, etc. have added to the list of their problems. Noteworthy that, the effect of floods in some areas was so intense that people have abandoned their houses and started settling away from the river (Fig. 8 & 9).

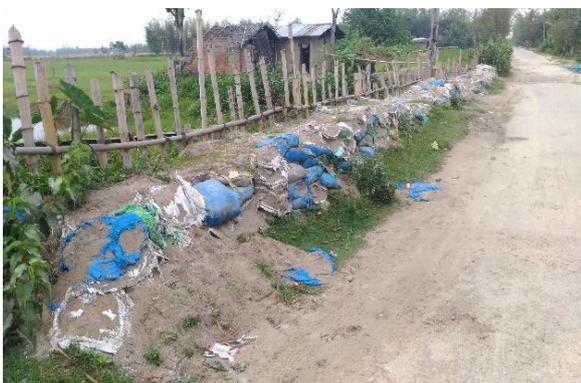
Fig 10: Protective measures adopted by the villagers

The people of Dolokhat village also has its own ways of adapting to the wraths of floods. The people of the village try to mitigate the floods by giving obstruction to erode and breach its banks. Bamboos and bags filled with sand are used to prevent the banks from erosion (Fig. 10). Again, banana tree rafts are used during floods as transport for carrying humans as well as their properties. On the other hand, during floods, temporary settlements of tarpaulin (locally called as *tirpal*) are made in the uplands to protect and save themselves from floods.
