Defect Analysis on Boeing 737-400 Skin Panel Rivet Row Aft Ward Fuselage

Mohammad Iqmal Mohd Ali, Azri Imran Hussin, Md Khairul Amiza Md Hairudin

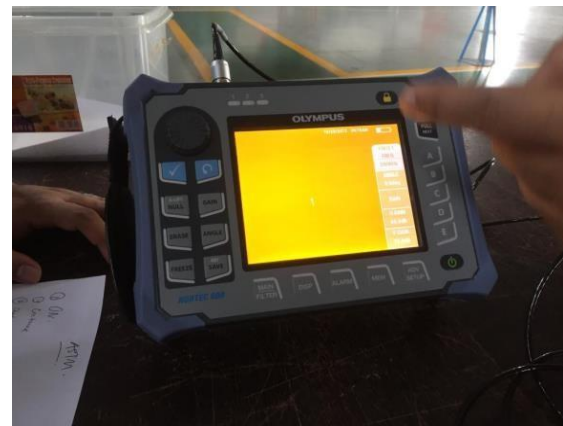
Fig. 2 Eddy current Olympus display

All three procedures require two tools: Eddy current Olympus display and Eddy cable; the different ones would be the probes used and the referred documentations. All the tools and reference documentations used during this entire research process have been are still being used for training aircraft maintenance technicians at an Approved Training Organization by Civil Aviation Authority Malaysia [8]

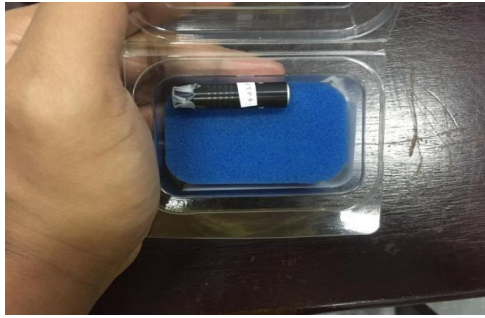
Fig. 4 Flat-surface probe

Flat surface probes must be used. Select probes which operate at the necessary frequency. Usually probes with small active diameters are better because they find small areas of corrosion more accurately. These probes are used:

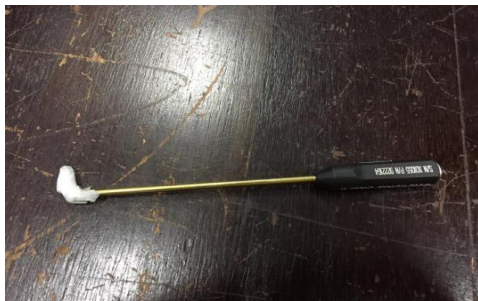
Fig. 5 90° probe

This eddy current procedure to help find cracks that extend from a fastener location in fuselage skins where the fastener head cannot be seen because of decals.

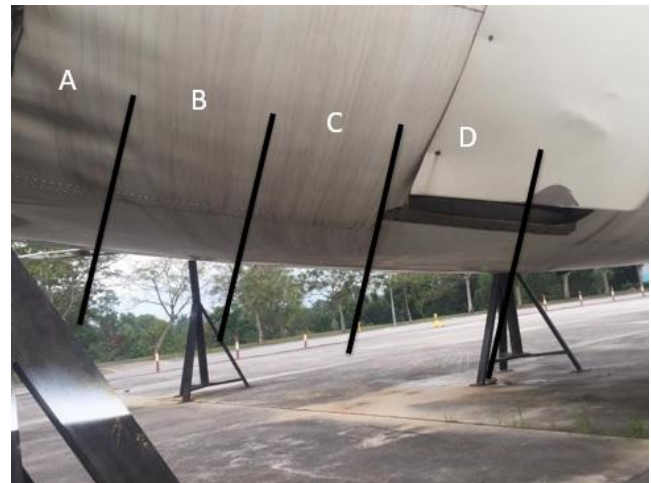
Fig. 7 Inspection Zones

The body station at the Boeing 737 from BS 747 to BS 967 has been divided to 4 Zone which is Zone A, Zone B, Zone C and Zone D. The Zone was divided to 4 section with 10 rivet panel on each Zone. This Zone was developed for research purpose as evidence showed in Figure 7.

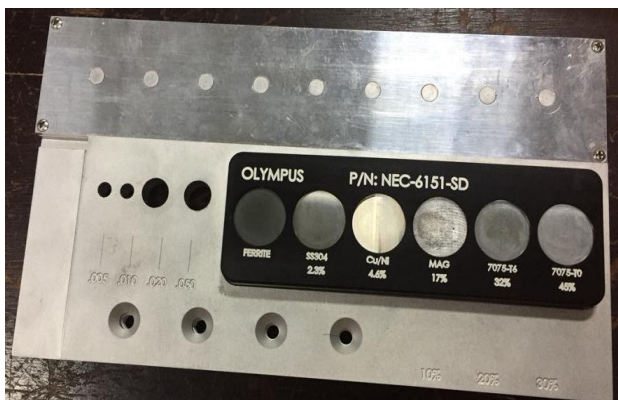
Fig. 10 Olympus conductivity Standard Reference

For the analyses data, conductivity test is required to know the usability of the rivet panel. The inspection for conductivity on the rivet row skin panel Zone A to Zone D calibrated via Olympus Standard Reference using aluminum alloy 7075-T6 32% and aluminum alloy 7075-T0 45%. Standard reference is shown as Figure 10.

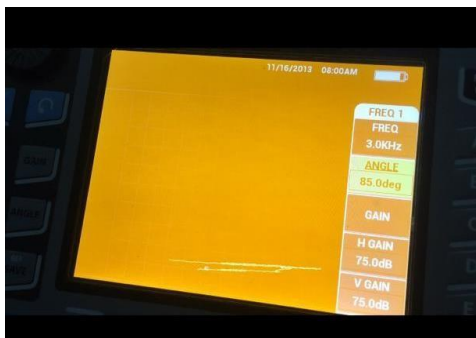
The result for the material loss test is gain and the data was referred to the Olympus Standard reference. The line if it cross to one grid is considered that the sub surface has 10% of material loss. This is shown in Figure 11. Line that cross on three grids is considered the sub surface has 20% material loss as shown in Figure 12. For line that across on four grids is considered that the sub surface has 30% of material loss as evidence in Figure 13.

Fig. 11 10% of material loss

Fig. 12 20% of material loss

Fig. 13 30% of material loss

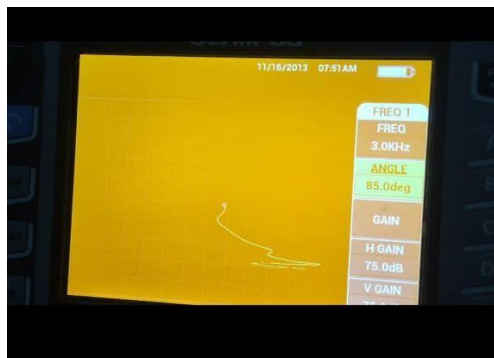
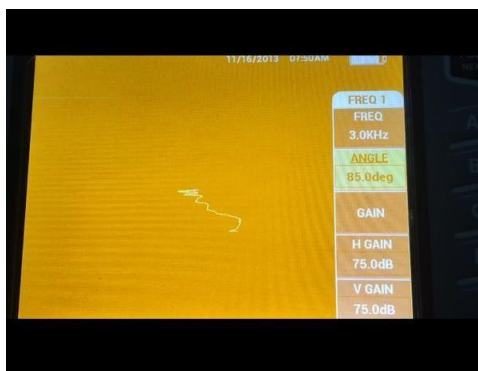
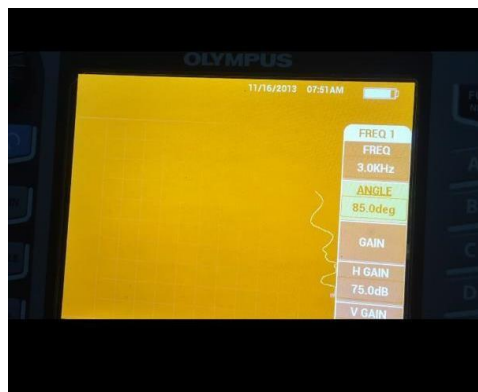
The result for crack test is gain and the data was referred to the Olympus Standard reference. The line if it cross on one grid is considered that the sub surface has 0.0598-inch crack. This is shown as Figure 14. Line that cross on three grids is considered the sub surface has 0.1601 inch as shown in Figure 15. For line that across on four grids or more is considered that the sub surface has 0.2004 inch of crack or more as evidence in Figure 16.

Fig. 14 0.0598 inch of crack

Fig. 15 0.1601 inch of crack

Fig.16 0.2004 inch of crack

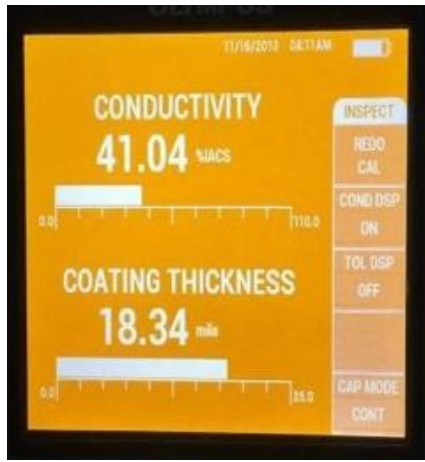
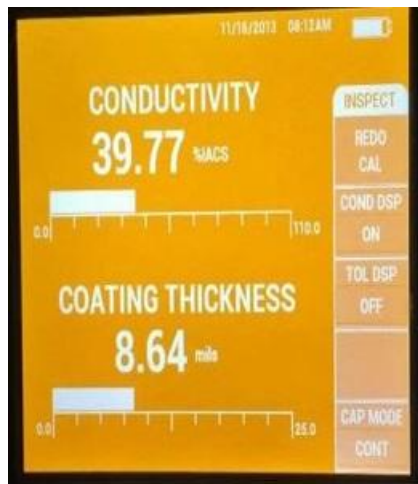
Fig. 17 Comparisons of Conductivity Test Results

The result for conductivity test is gain and the data was referred to the Olympus Standard reference using alloy 7075 Temper (0). The percentage shows the conductivity gain at the subsurface that in contact with the probe. The conductivity percentage is then converted to hardness as per Figure 18. Hardness testing determines the material's resistance to plastic (permanent) deformation and brittleness. This correlates directly to the strength and wear resistance of a part. If the value is below the limitation the subsurface is affected by deformation whereas if the value exceeds the limitation it is affected by brittleness. Figure 17 shows the comparison of the results for the conductivity test at the fuselage BS 747 to BS 967.
