Assessment of Road Safety Audit of NH-69, Karnataka State, India

The project stretch considered is NH-69 (Bhadhravathi to Shivamogga – Karnataka State) ranging 22.1 Kms. The present study deals with road inventory, signage inventory, traffic volume count survey, spot speed study, Speed and delay study and other surveys such as topographic survey and Accident data has been collected for the stretch for a period of 2012-16 is collected and analysis is carried out. The study aims to evaluate Road Safety Audit of a section of four-lane National Highway (NH)-69 and will focus on evaluating the benefits of the proposed actions that have emanated from deficiencies identified through the audit process. Missing road and median markings to be done and speed signs should match with speed. Access and service lanes are also deficient which requires immediate improvement.

A portion of NH-69 was selected for project. The selected stretch has a bypass portion of Bhadravathi. The stretch starts from Km 183.100 (at joining of bypass and NH-69) and ends at Km 205.2 (at MRS circle). The length of study section is approximately 22.1 Kms.

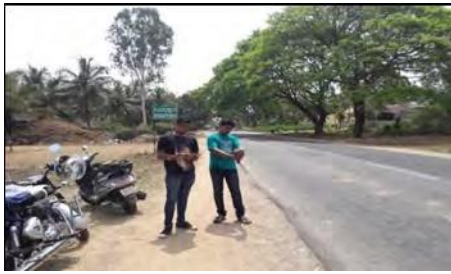
Spot speed is the instantaneous speed at a particular section or a point. There are different methods are used. In the first method, the time taken by the vehicle to travel a short distance is determined. Then the instantaneous speed is determined. Then the instantaneous speed is measured by pre calibrated radar equipment which displays or records the speed in desired units such as kmph. In this project, Radar Gun is used.

Fig. 4: Spot speed study using RADAR

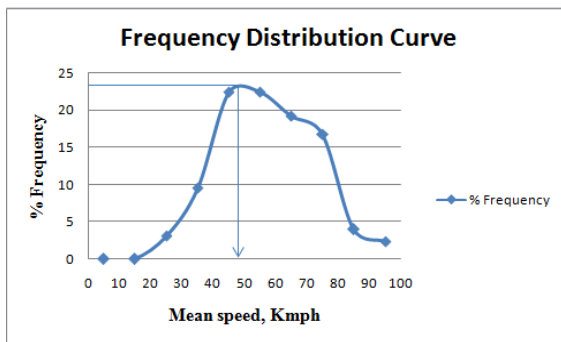
Frequency distribution of spot speed data				
Speed range Kmph	Mean speed Kmph	Frequency	Percentage frequency	Cumulative frequency
0-10	5	0	0	0
10-20	15	0	0	0
20-30	25	4	3.2	3.2
30-40	35	12	9.6	12.1
40-50	45	28	22.4	35.2
50-60	55	28	22.4	57.6
60-70	65	24	19.2	76.8
70-80	75	21	16.8	93.6
80-90	85	5	4	97.6
90-100	95	3	2.4	100
Total		125	100

Fig. 5: Frequency Distribution Curve

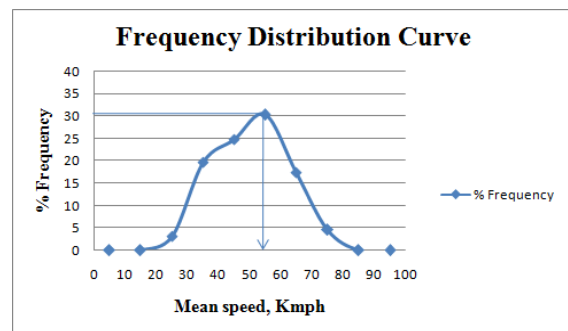
Frequency distribution of spot speed data				
Speed range Kmph	Mean speed Kmph	Frequency	Percentage frequency	Cumulative frequency
0-10	5	0	0	0
10-20	15	0	0	0
20-30	25	11	3.14	3.14
30-40	35	69	19.7	22.84
40-50	45	87	24.85	47.69
50-60	55	106	30.28	77.97
60-70	65	61	17.42	95.39
70-80	75	16	4.57	100
80-90	85	0	0	100
90-100	95	0	0	100
Total		350	100

Fig. 7: Frequency Distribution Curve

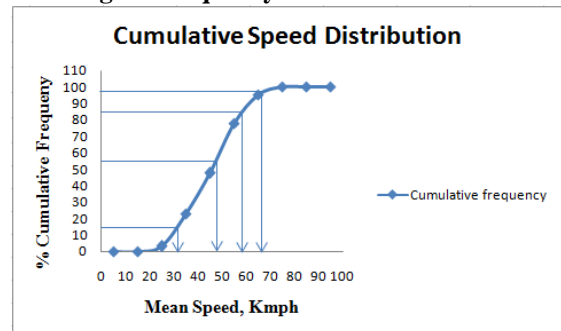
Design speed (98thpercentile) = 68Kmph. Maximum speed (85thpercentile) = 60Kmph. Minimum speed (15thpercentile) = 31Kmph.

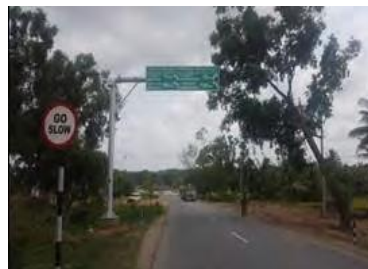
Fig. 10: Road inventory at 194.300 Km

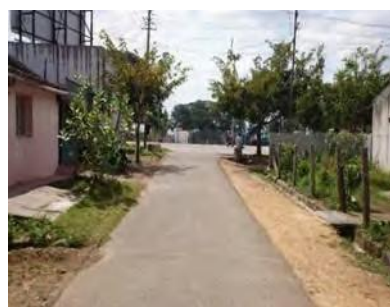
Fig. 11: Lack of sight distance

In selected stretch more number of T- Junction are present. Most of these junction have poor sight distance for the minor roads due to the presence of vegetations, buildings etc. and also signboards are not installed; speed breakers are not used in minor roads.

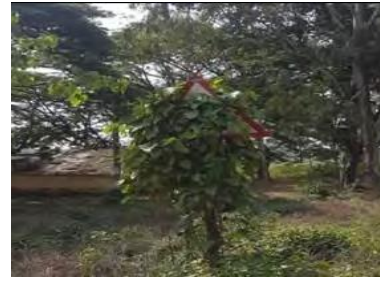
Fig. 14: Sign board covered with vegetation at ch.188.100 Km

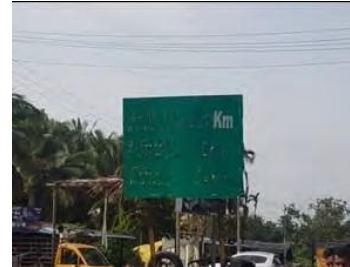
Fig. 15: Poor condition of sign Board at ch.190.100 Km

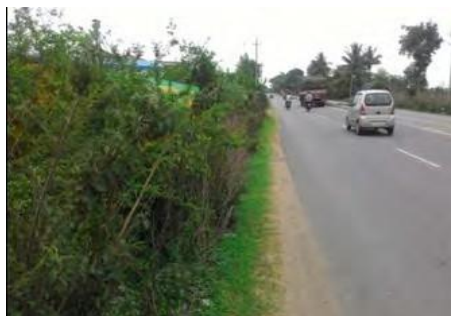
From the road inventory survey, width of shoulder at the selected stretch is not as per IRC standards. The width is varying from 0.3m to 3.0m. Due to the poor maintenance of shoulder vegetation covers the width of shoulder (earthen shoulder) and the strength of shoulder is poor. The fig.15 and fig.16 showing poorly maintained shoulder of inadequate width and strength. During rainy season condition of shoulders would worsen, results in the drainage problem and condition of the pavement may be effected.

Fig. 12: Inadequate width of shoulder

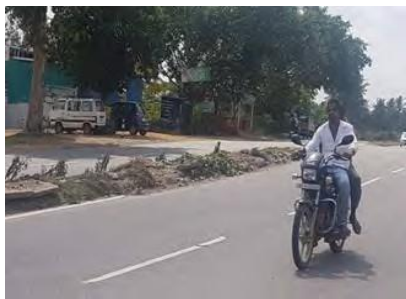
Fig. 13: Damaged median at ch.202.300 Km

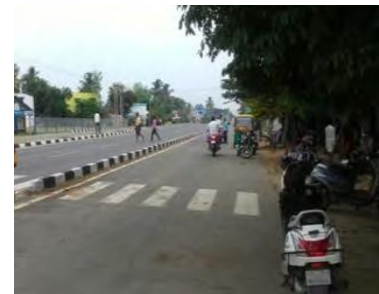
Fig. 16: Poor visibility of Bus stop at ch.197.300 Km

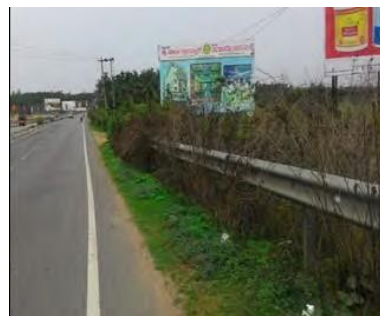
Fig. 17: Vegetation covering over barrier

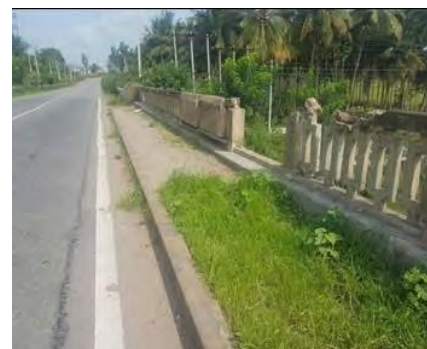
Fig. 18: Damaged parapet
