Analysis on the stability of rubble mound breakwater and wave overtopping phenomenon

Kyu-Han Kim, O-Gi Kwon, Kyu-Tae Shim

Abstract: *This study, by Physical Model Test, has reviewed the displacement of blocks and wave overtopping due to the external force change when constructing breakwater as a counter facility in the area of Nghi Son of Vietnam, where the construction of a Refinery & Petrochemical Complex is planned. The front of the breakwater is coated with two layers of RAKUNA-IV, which is concrete armor unit. 100yr Return Period Tidal Level ($C.D+5.45m$) and 100yr Return Period Storm Wave (H_{m0} : $3.7m$, T_p : $11.8sec$) are set for the design wave condition to take into account the influence of sea-level rise caused by global warming. The test revealed that the stability of the blocks against the occurrence of incident waves is affected by wave run-up at the front of the breakwater, wave overtopping discharge and JET flow between blocks. Also, it found that there was displacement of blocks at the crest and rear slope of the sections without any coping concrete along with local exposures of core stone. Therefore, cap concrete on the breakwater was installed to decrease wa

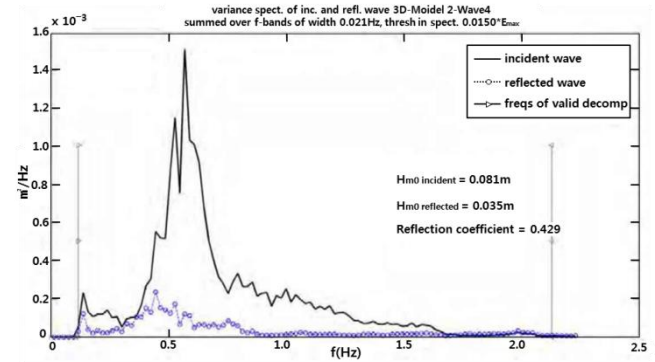
Fig 5: Spectrum of wave 4 (H_{m0} :4.05m, T_p :12.40sec)

above Figures 4~6 show the wave spectra applied to the experiment. Among the scenarios, Waves 3, 4 and 6 are shown representatively, and experiments were conducted based on the measured values. The measured values were found to be similar to each other in comparison with the target value.

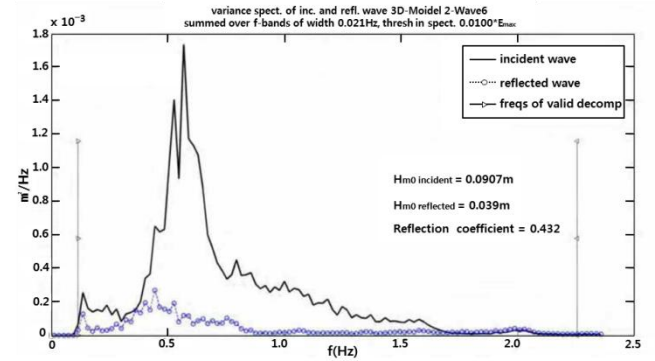
Fig 6: Spectrum of wave 6 (H_{m0} :4.55m, T_p :12.40sec)

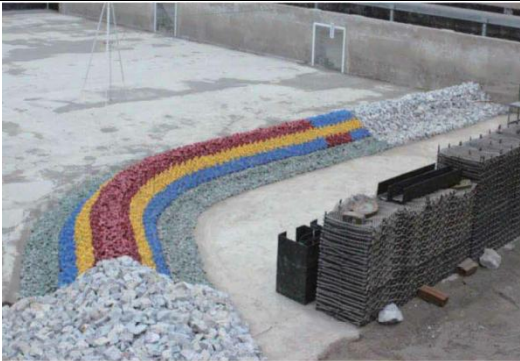
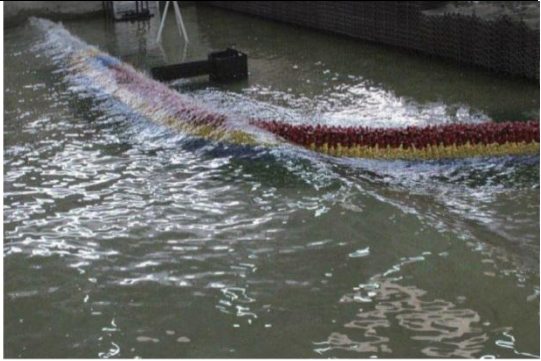
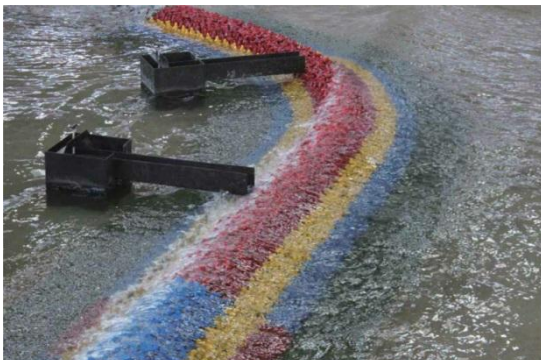
Table 4: Test scene of bend part under wave 4 condition with NE dir.

Condition	Result of before and after wave generation	Under attack of wave 4
Original (planned) design Condition

the major external force for stability of breakwater, are shown in Tables 4 to 7.

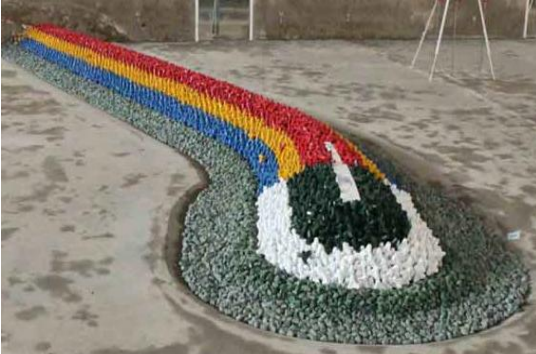
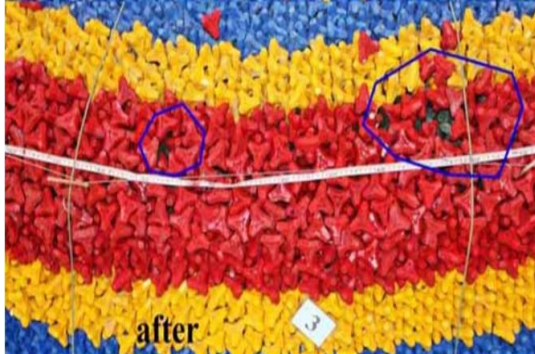
Table 5: Test scene of round head part and major trunk part under wave 4 condition with NE dir. (original design)

Condition	Result of before and after wave generation	Under attack of wave 4 and result
Original (planned) design condition

stability. During the test, from the attack of Wave 2 (10yrs.) the displacement took place independently at the Root Part, Bend Part and Round Part. At the Roundhead part and Major Trunk part, there was a large amount of overtopping discharge in the scenario of NE Wave 4 (100 yrs.). A complex flow occurred when the sea-water passed between the blocks mounted on the crest and the strong flow caused the displacement of blocks mostly mounted on the crest. Most displacements of blocks occurred at the straight sections of the Trunk part along with local exposure of the core filter. The cause of the intensive displacement of blocks on the crest part compared to the slope is that interlocking is weaker than the slope part of the block installed. When the overtopping happens, the moment force at the rear side of the shoulder part due to sea-water is increased. Though the displacement rate of the block was only 0.4%, it was determined to be unstable in Wave 4 (100 yrs.) conditions since it is regarded as Serious when the standards of Table 2 were applied. A plan to extend cap concrete from the major trunk part to the bend part in order to control the jet flow passing between blocks mounted on the crest was reviewed as a counter-measure against this. As seen in Table 4, the penetrating flow velocity was controlled during the Wave 4 (100 yrs.) scenario where the revised cross-section and the decrease of block displacement caused by overtopping led to no filter stone exposure which would occur due to the displacement. After repeating the test three times, the displacement rate of blocks was found to be 0.07%, 0.08%, and 0.06% respectively, and accordingly the stability was considered to be secured since the damage levels were very little. In the case of Wave 5 with the tide level 1.25 meters higher than Wave 4 (100 yrs.), the overtopping rate in the test duration significantly increased compared with that in the conditions applied in Wave 4. This was thought to be a phenomenon whereby the overflow depth deepened as a result of the relatively lowered freeboard (R_C) and the strong wave run-up and overflowing of the breakwater crest increased the rotation component to cause the displacement. The increased wave condition caused local exposure of the core. In the Wave 7 scenario where the wave is 1.2 times as high as that in Wave 4, the overtopping rate was more than that in Wave 4 and there was some exposure of the core due to block displacement as in Wave 5. However, since the two cases were for the only analysis of phenomena by scenario, the test result was not reflected in the design and construction. By applying these test results to understand what the difference in the number of blocks displaced would be when the crown concrete was extended and when not extended and to appreciate the correlation between ratio of wave height and water depth (H_{m0}/D) and wave steepness (H_{m0}/L) the range of stability by parameter and block displacement could be secured. As seen in Figure 7, when there were about 15 displaced blocks, the core was exposed, and with more external force than that in Wave 4 on the cross section of an original trunk part design there was local exposure. When the crown wall was extended, there was stability in Wave 4, while in Wave 5 and 7 the overtopping caused the exposure of the core part. According to the analysis of stability by changes in wave steepness (Figure 8), it was found that the steeper the wave, the more block displacement occurred. In particular, there was a drastic change in the trunk part. As seen in Figure 9, the analysis of damage parameter and relative wave revealed that there was the displacement of the biggest block in Wave 5 (H_{m0}/D : 0.33~0.36) with relatively low R_C . In spite of the relatively low H_{m0}/D , there was a high damage rate, the reason for which was that the increase in tide level caused the decrease of R_C resulting in the increase of overtopping. The examination of the

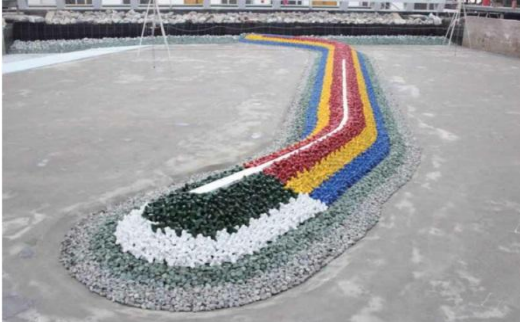
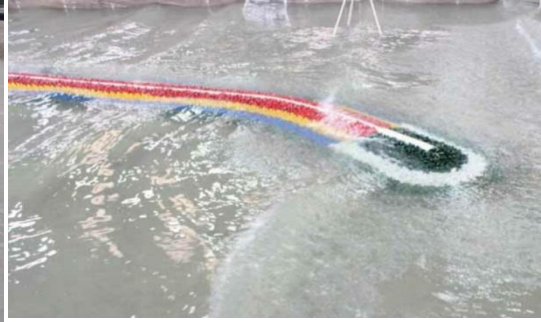
Table 6: Test scene of round head part and major trunk part under wave 4 condition with NE dir. (revised design)

Condition	Result of before and after wave generation	Under attack of wave 4 and result
Revised design condition

The test showed that the movement of blocks decreased remarkably when the penetrating flow was controlled by the installation of cap concrete on the top; on the other hand, it was confirmed that the increase of the overtopping rate due to higher water-level and higher wave height in the same circumstances of a cross section accelerated the displacement of the armor unit and at the same time was found to be the main reason for the worsened stability of the rubble mound breakwater.

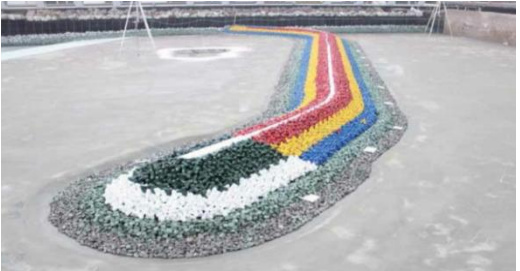
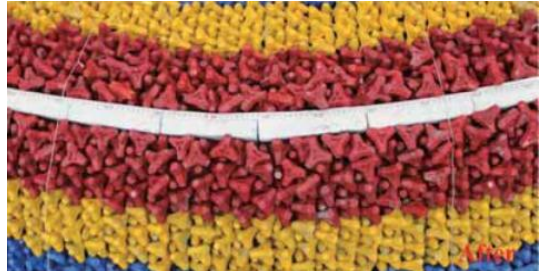
Table 7: Test scene of round head part and major trunk part under wave 4 condition with SE dir. (revised design)

Condition	Result of before and after wave generation	Under attack of wave 4 and result
Revised design condition

round head & trunk part for SE wave in the circumstances of a cross section at the extended crown wall revealed that there was stability in Waves 4 and 7. However, in Wave 5 with a higher tide level, overtopping caused intensive displacement of blocks on the sides of the trunk part and crest part and rear part.

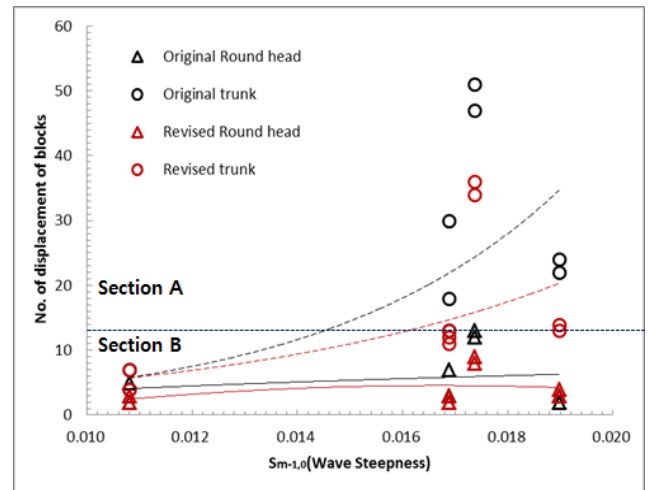
Fig 8: Relationship between Wave steepness and number of displacement blocks

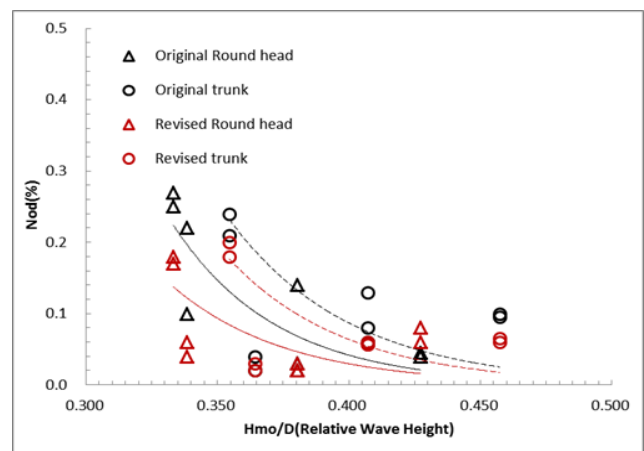
Fig 9: Nod values about extension of crown wall (Round head & trunk part)

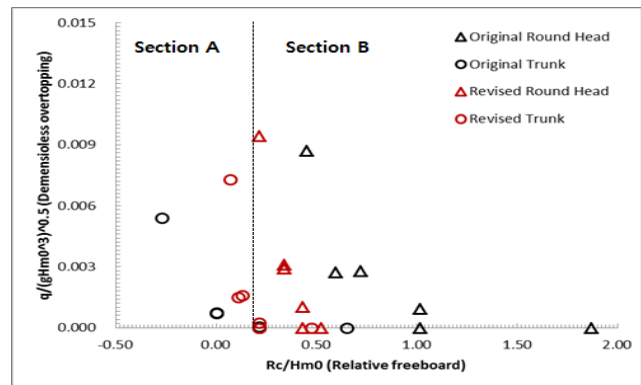
Fig 10: Relationship among wave overtopping, freeboard and wave height

Here, q is the mean overtopping discharge per meter structure width ($m^3/sec/m$), g is acceleration due to gravity (m/s^2), H_{m0} is the estimate of significant wave height from spectral analysis (m). In figure 10 is shown the relative freeboard (R_c/H_{m0}) of the dimensionless value. In Figure 10, the conditions of overtopping occurrence and exposure of the core part are distinguished - the analysis revealed the section A with the condition of $R_c/H_{m0} < 0.2$ was unstable due to the exposure of the core part. These outcomes are based on changes to cross sections on the round head and major trunk part and overtopping rate by scenario. Next, the correlation between overtopping by the changes in parameters employed for this test and the dimensionless value was investigated to conduct an analysis on the relationship between stability and overtopping occurrence by tide level and waves acting on a breakwater. Figures 11 and 12 show the comparative results of the relative overtopping rate (Q) and relative freeboard (R) in the conditions of the cross section from round head to bend part, incident wave direction and

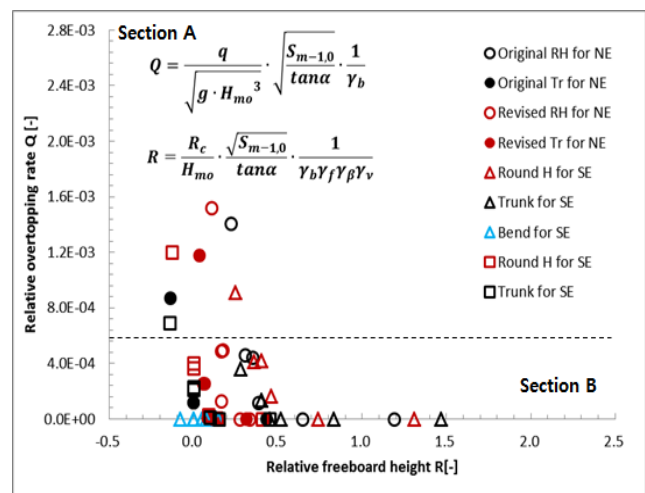
Fig 11: Analysis on Stability of breakwater depending on the Q & R

Here, R_c/H_{m0} is relative freeboard, γ_b is influence factor for roughness elements on a slope [-], γ_β is influence factor for oblique wave attack [-], γ_v is correlation factor for a vertical wall on the slope [-]. The analysis found that Sections A and B could be distinguished on the point of 6.0E-04 on the y-axis, when Section A is an area deemed "Serious" because of the core exposure caused by overtopping with the consideration of Table 2. There is local displacement of blocks at Section B, while there is no core exposure and also N_{od} (%) is the area within 5%. Accordingly, Section A may be thought of as the area with stability unsecured. The following Figure 13 shows the relation of the breaker parameter ($\xi_{m-1,0}$) to formula (2) of the dimensionless overtopping rate that has been converted to a natural log value, where $\xi_{m-1,0}$ is expressed in the following formula.

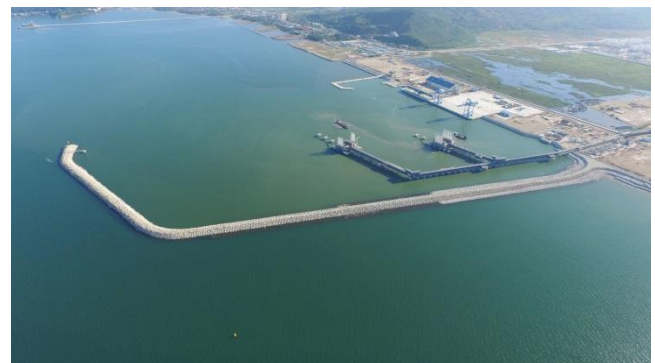
Fig 14: Analysis on Stability of breakwater depending on the wave overtopping discharge and breaker parameter
