# Inspection Analysis of Historic Buildings with Aid of “Unmanned Aerial Vehicle” (UAV)

**Index Terms:** Unmanned Aerial Vehicle (UAV), CSP1 Matrix, Historical Assessment Building Survey (HABS), Building Defect

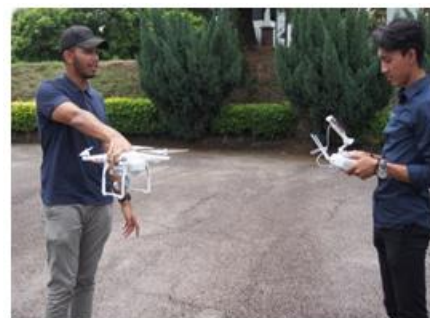
Fig. 3 Calibration process of Phantom 3 before take-off

On both museums, visual inspection was used to detect all of the defects occurred. The purposes of acquiring and analyzing data which then can be proceeded with quality control. The data gathered was carried out by an UAV for called Phantom 3 for defects above the first floor and a cameraman for defects that occurred on the ground floor or below. Furthermore, this UAV could fly for 23 minutes total and about 5km range radius flight with a live 720p HD view of what the camera sees [13]. This feature makes this UAV to reach on top of the buildings easily [14]. Figure 3 shows the calibration process of an UAV before take-off.

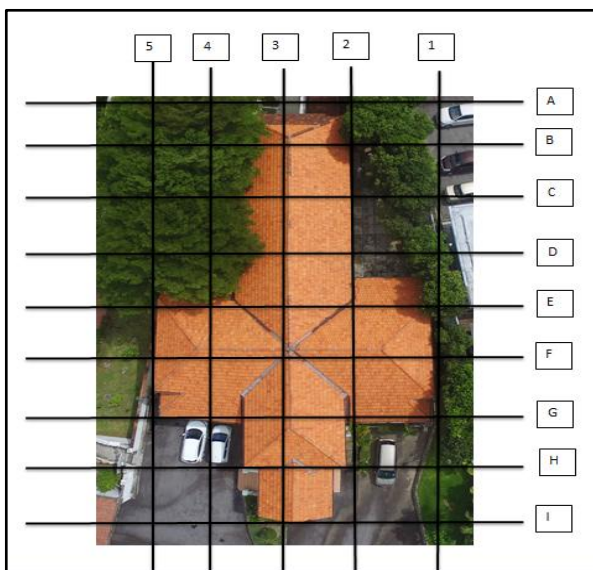
**Fig. 4 Example of gridline at roof structure for Melaka Literature Museum**

In Malaysia, historical buildings are different from one another in terms of architectural style, function, structure and building defects which require a comprehensive approach to building conservation and systematic. [16] In order for this assessment to be easily analyze parts of the museum are being separated using grid line. Figure 4 shows an example of gridline at roof structure for Melaka Literature Museum. Each grid line can be referred after this inspection for further actions for the maintenance to take parts afterwards.

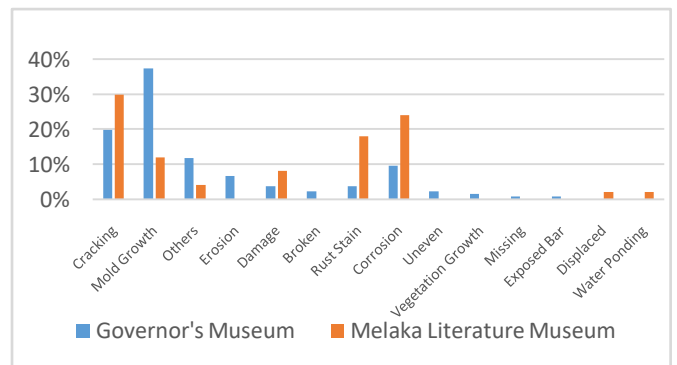
**Fig. 6 Percentages of building defects that detected occur on both museums**

Figure 6 shows the percentages of building defects that detected occur on both museums. Mold growth (38%) of building defect leads the other types of building defect that occur on Governor's Museum followed by 20% cracking while for Melaka Literature Museum the highest percentage of defects was cracking (30%) followed by 24% of corrosion. Another types of building defect occurred can be figured out based on data graph given in Figure 6 below. Before conducting any maintenance action to the buildings, it is more advisable to study in advance every possible causes of building defect and damage in order to avoid the same defects or damage from recurring.

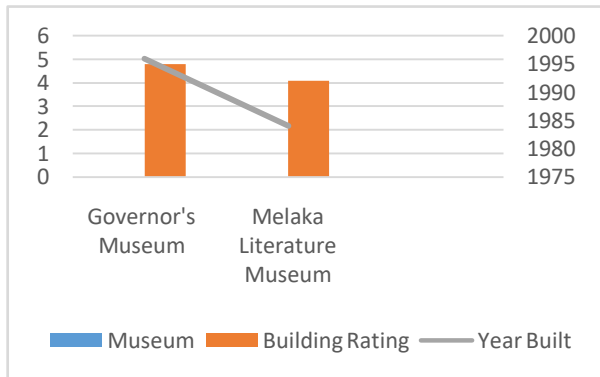
Fig. 7 Rating of museum vs year of built

Based on Figure 7, it shows that Melaka Literature Museum have a smaller rating compared to Governor's Museum. Although the Governor's Museum was built in 1996 but it has the highest rating compared to both museums. Despite all of that, gap of year between both museums are about 12 years different of years of built where Melaka Literature Museum was built around 1986 nevertheless with proper care it will be still in a good shape. The museums undergo an effective maintenance for their structures because both of it are still in good condition.

Table 1 shows overall building ratio as stated in CSP1 Matrix [17]. By referring to that table and Figure 7, it showed that both museums are in Good condition. This is because the rating are 4.8 for Governor's Museum and 4.1 for Melaka Literature Museum.
