Analysis of Pathological Manifestations in Buildings at The University City Prof. José da Silveira Netto, Located in Belém-PA

Catarina de Nazaré Pereira Pinheiro, Adriene Rodrigues Barbosa

Index Terms: Building Pathologies Evaluation; Case Study; Pathological Manifestations

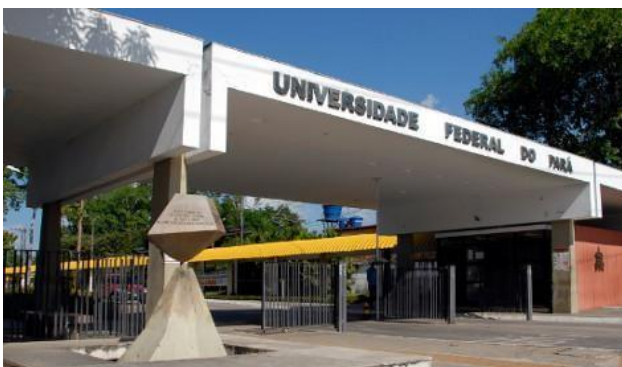
Fig. 2: Federal University of Pará (Source: UFPA Website, 2019)

In this study, concrete structures were analyzed in some buildings of Cidade Universitária José da Silveira Neto, located in Belém-PA (Figure 01). The city is home to the Belém campus of the Federal University of Pará (Figure 02), with a territorial area corresponding to approximately 3,328,655.80 m² and a built area of approximately 204,930.90 m².

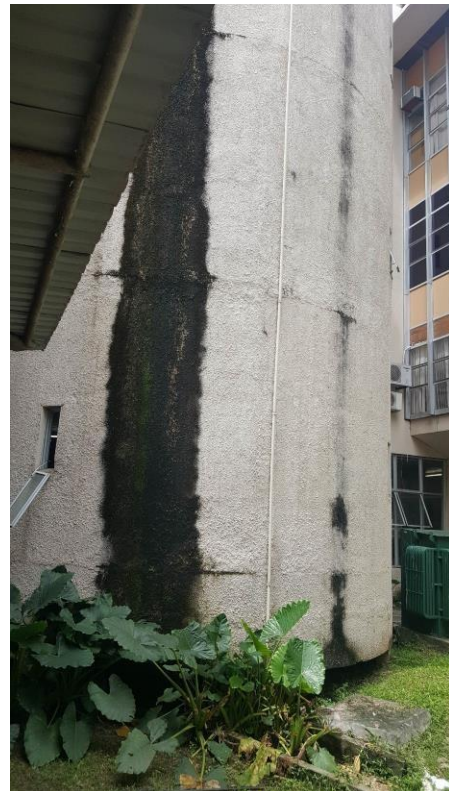
Fig. 3: Microbiological attack (Source: Author's Collection, 2019)

In the building of the rectory of the Federal University of Pará, the high moisture content, combined with the presence of some cracks and the material itself, contributed to the

appearance of biological agents such as fungi in the concrete structures present in the building, in some cases, compromising the integrity of parts of those structures. (Figure 03).

For the manifestations identified, the solutions proposed below were based on the scientific literature reviews. Problems related to biological agents can be solved by performing cleaning of contaminated surfaces and, where necessary, using fungicidal solutions and reconstitution of the concrete at more extreme levels of deterioration. For the vegetation, the main indicated solutions are the manual withdrawal or the use of herbicides, followed by the filling of the open joints or fissures.

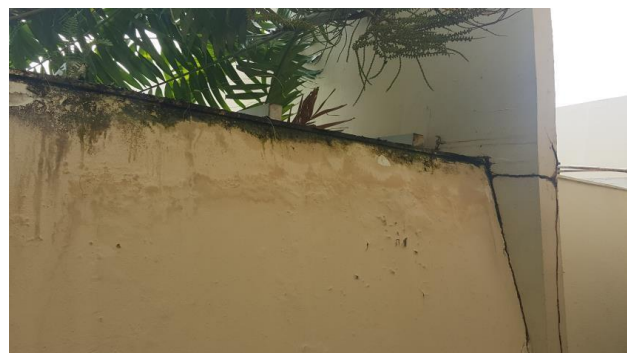
Fig. 4: Presence of vegetation (Source: Author's Collection, 2019)

In addition to the microorganisms, in this building, there was a great presence of vegetation in the building (Figure 04). According to [11], there are two types of pathologies linked to plant life. The first is related to the emergence and proliferation of small algae in very porous concretes or cracks, and its main cause is the moisture present in the site. The second type refers to the appearance of cracked plants, which to a large extent can cause structural damage or even collapse of the building.

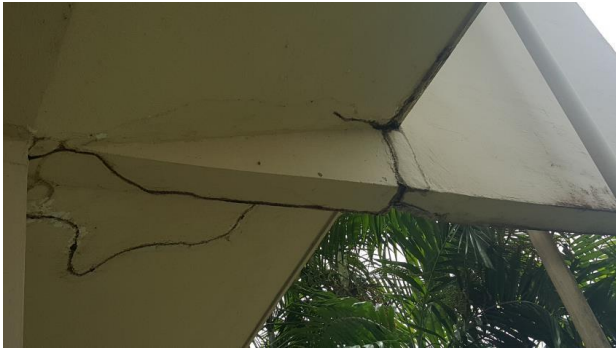
Fig. 5: Concrete segregation (Source: Author's Collection, 2019)

In the rectory, some cracks and disintegration of the concrete were also found in parts of the structure, possibly caused by the material being in contact with the aggressive environment and by the presence of the biological agents, in the case of segregation (Figure 05). In a

previous visual analysis, no indication of structural problems was found in this building.

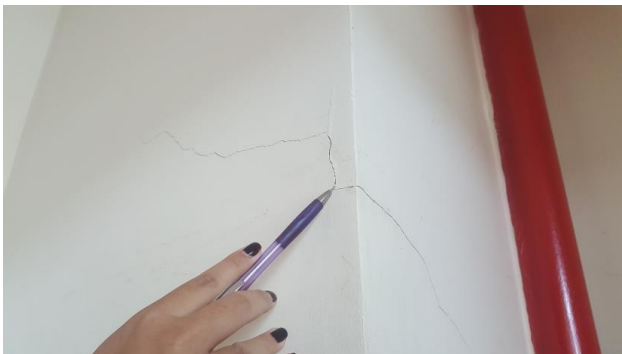
Fig. 6: Structural Problems (Source: Author's Collection, 2019)

The Center of Events Benedito Nunes has fundamental importance for the university because it receives the main academic events of the institution. In the concrete structures present in this building, problems were found, mainly of a structural nature, with the incidence of inclined, horizontal and vertical cracks in the pillars, beams and walls, which in a preliminary analysis are caused by mechanical loads of the structure (Figure 06).

During a previous visit to the building in 2016, several fissures could be observed, which were later corrected. However, in the year of this study, in 2019, it was noticed the reappearance of some cracks, mainly in the pillars of the structure, which indicates these cracks encountered are in a active condition, pointing to a lack of solution to its causative problem. In addition to the pathologies highlighted above, the event center still presents several pathological manifestations of a constructive nature, which were addressed by [8].

For manifestations related to foundation, fissures and cracking problems, [5] recommends strengthening the foundation or the relief of load through a specialist in the area, the preparation and cleaning of cracks or cracks, and the injection of epoxy resin. For cracks and cracks arising from structural problems, appropriate structural reinforcement is recommended.

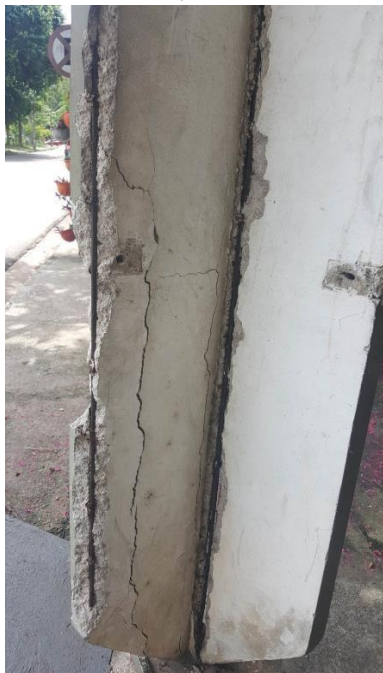
Fig. 7: Corrosion Process (Source: Author's Collection, 2019)

Most of the pillars of the footbridges that existed within the University City presented the corrosion process, which in some cases was quite high (Figures 07 and 08). The exposure of these structures to the external environment, with higher aggressiveness, was what possibly propitiated the phenomenon.

[5] proposes as a solution to steel corrosion problems in reinforced concrete structures, the careful removal of the region affected by the phenomenon and the products that generated the corrosion by cleaning the surface and reconstituting the original section of the reinforcement. For cases with corrosion without compromise of concrete and steel bars, the author recommends the recovery of the structural element with the use of mortar based on

cement, epoxy, or polyester, increasing the covering of the section when it is below that specified by the standard. In cases of structural element impairment, the author recommends reinforcement with increased section of the component. Finally, after reinforcement, the author recommends the application of protective coating on the structure.

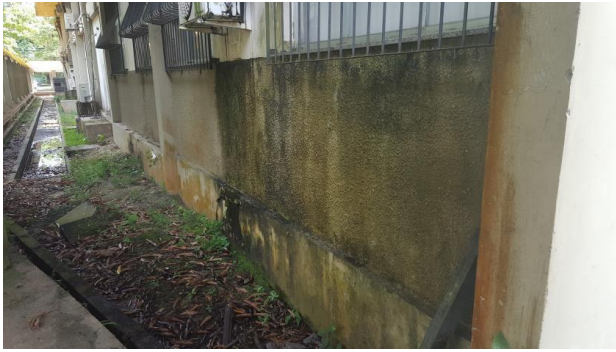
Fig. 9: Biological agents (Source: Author's Collection, 2019)

In the classroom pavilions, the concrete structures, in general, presented problems with biological agents

(Figure 09), which, as in the rectory building, had as main cause the presence of moisture in the place.

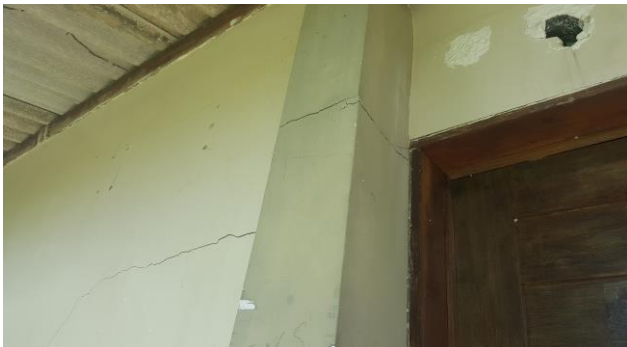
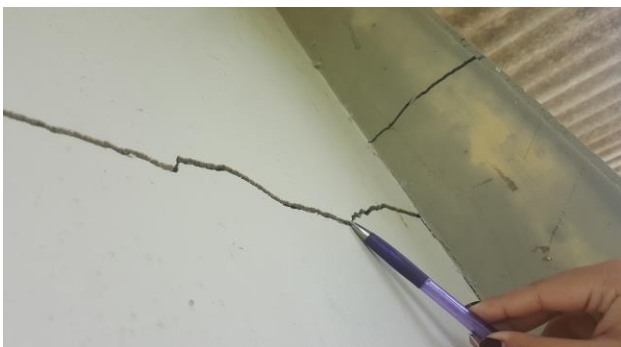
In addition, in the pavilions, there were several fissures and cracks in the beams, pillars and walls, caused by structural and structural problems. It is worth mentioning, in these buildings, the cracks caused by foundation problems. (Figures 10 and 11)

Fig. 10: Foundation Problems (Source: Author's Collection, 2019)

Fig. 11: Foundation Problems (Source: Author's Collection, 2019)

Previous studies of the soil inside the University City have verified the predominant presence of clay in great depths. Due to the low resistance of this type of soil, it is common the greater incidence of problems of foundation, which was proven by the diverse manifestations found throughout the university.

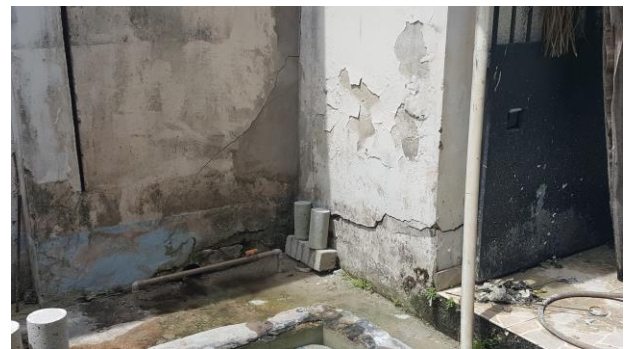
Fig. 12: Biological agents (Source: Author's Collection, 2019)

In the building of the university's Civil Engineering laboratory, several manifestations, similar to those mentioned above, were found. The presence of several fissures and cracks, caused by the structural and construction problems previously mentioned, and the presence of vegetation and biological agents in the structures (Figures 12 and 13)
