Application of UAV and Csp1 Matrix for Building Inspection at Muzium Negeri, Seremban

Abstract: Building inspection is really essential to determine the condition of a building and one of the key components of building maintenance. To determine the defect, visual inspection will be conducted as early phase of building inspection. Usually, binocular and camera will be used as main devices in visual inspection. This research aims to study Museum Negeri defects at exterior structure especially the roof structure by using the Unmanned Aerial Vehicles (UAV) or as known as Drone. The data collected will be analyzed using Condition Survey Protocol I Matrix to obtain an overall rating of the building's condition. The process involved in this study are site visit, planning and preparation before the flight, data collection using UAV, image processing and analyzing data from image. The results of analysis, a total numbers of 53 locations have been identified and documented suffer from defects or faults such as cracking, corrosion and wall perforated. All defects information obtained using UAV visual inspection can help the museum maintenance to do maintenance work. The overall condition of

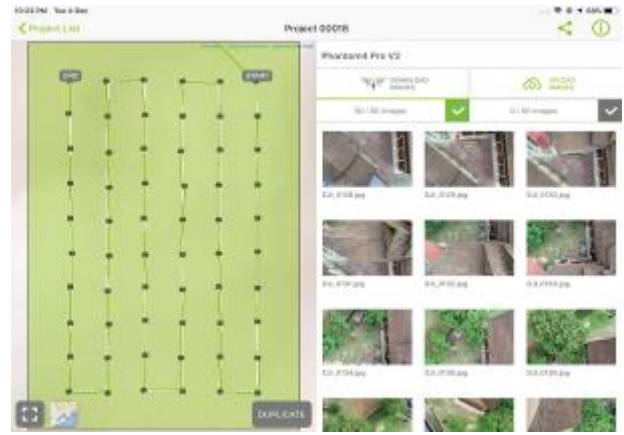
Fig. III: The movement of aircraft using Pix4D Capture

Due to the complex roof shape, auto capture is used by taking pictures from every angle of the roof using Pix4D Captures application. The Fig. III shows of an unmanned aerial vehicles flight plan for surveying the roof building and the total images is 60 images. For the wall building, the total image is 425 images. This result shows that the planning and preparation are successful as planned. The Fig. IV shows the UAV operator in controlling the remote control.

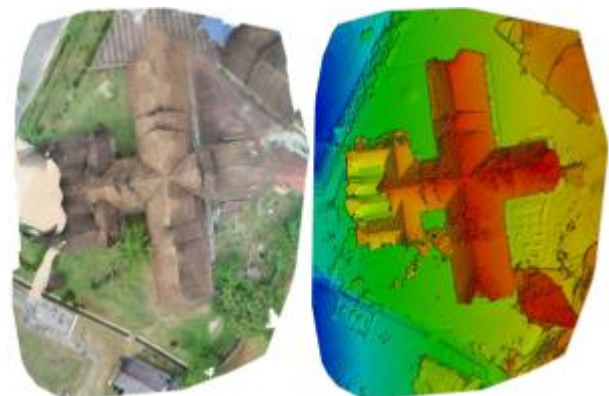
Fig. V: The process of roof images using Pix4D Mapper.

From the image have been taken, the images will be transferred from the UAV flight into the laptop for processing to get the high quality images. In this process, photogrammetry method is used in processing the roof images. The images taken for the roof will be process to get a complete image covering the entire of roof plan using the Pix4DMapper software. The Fig. V shows the images of roof building were processing in high quality result. Then, the complete image of roof building will be transfer into Global Mapper software and will be zooming in the display clearly to get the size and coordinate of the defects. The Fig. VI shows that the images were processing using the Global Mapper software.

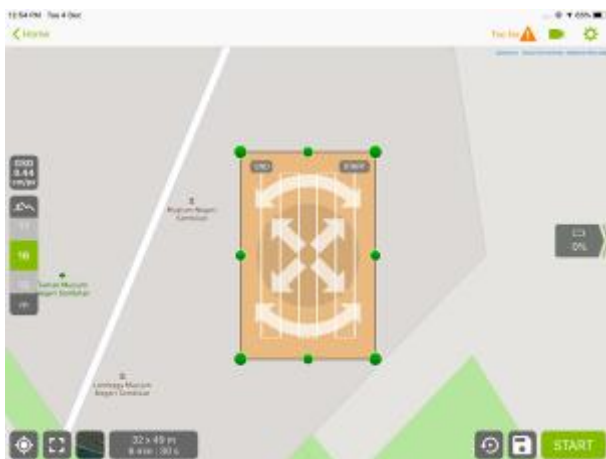
Fig. II: The coverage of study site have been set and ready to fly.

distances between the UAV micro aircraft and the building wall using DJI G0 have been set about 2m. The Fig. II shows in using Pix4D Capture, the period of UAV aircraft flew have been set about 6 minutes 30 seconds with the distance between UAV and the roof is 4 metres and 16 metres from the ground. The areas of location for fly have been set about 32m × 49m with the angle of the camera is 60°. The front overlap and side overlap was set about 70% and 80% with the aircraft speed is slow.

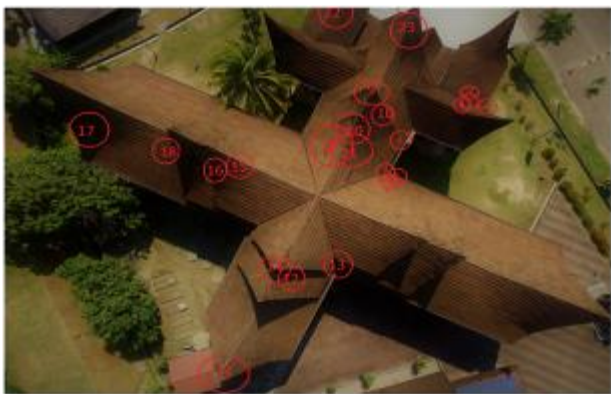
Figure VII: The location of defects for roof

All the entire images then will be undergoes the determination of the defect by using the *Condition Survey Protocol (CSP) 1 Matrix*. For more details on how CSP1 Matrix rating can refer to previous study by the author where using CSP1 matrix for building inspection at mosques in area of Pagoh – Muar, Johor [13]. Instead of a longhand description of a building’s defects, this matrix requires concise explanations about the defects identified, thus saving on-site time during a building inspection. The full score is used to give the building an overall rating which is Good, Fair or Dilapidated. In CSP1 Matrix consist of original image and then image after zooming process. Coordination of the defects have been set from the process in *GlobalMapper software*. The defect of the structure in Table 6 and Table 7 can be located by refer to the Fig. VII while the defect of structure in Table 8 and Table 9 can be located by refer to the Fig. VIII.

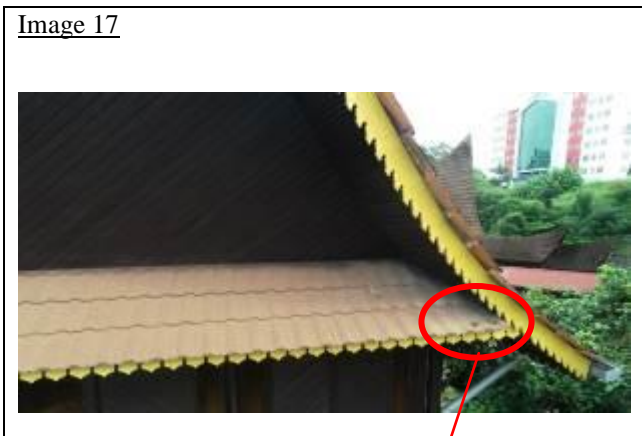
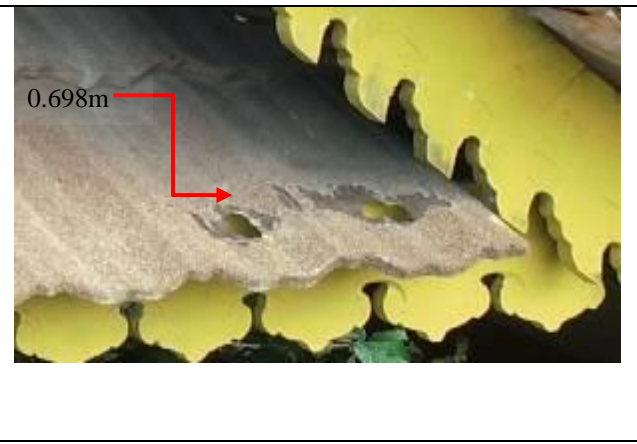
Table 6: CSP1 Matrix analysis for roof building (image 17)

Number of Defects : 1
Coordinate : 3.1933°N,14.1619°E

Condition	Priority	Matrix	Colour
5	3	15	RED

Element / components : Roof
Description of Defects : Perforated roof
Suggestion : replace the new roof

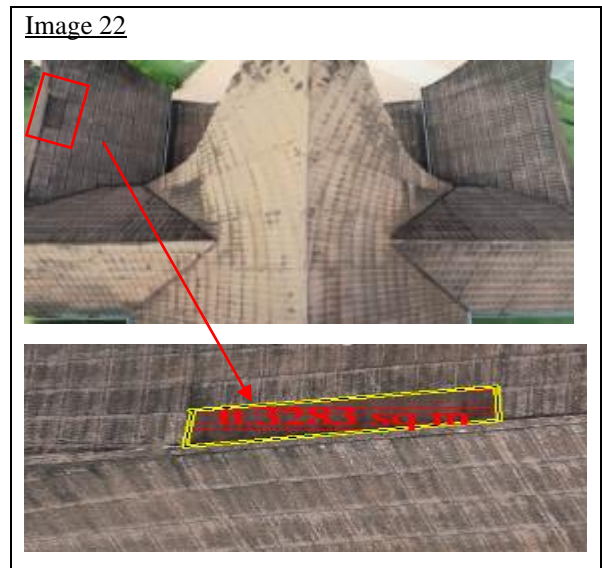
Table 7: CSP1 Matrix analysis for roof building (image 22)

Number of Defects : 1
Coordinate : 3.5116°N,13.4841°E

Condition	Priority	Matrix	Colour
2	2	4	GREEN

Element / components : Roof
Description of Defects :
 The area of the roof are rusted.
Suggestion : Change the entire part of roof

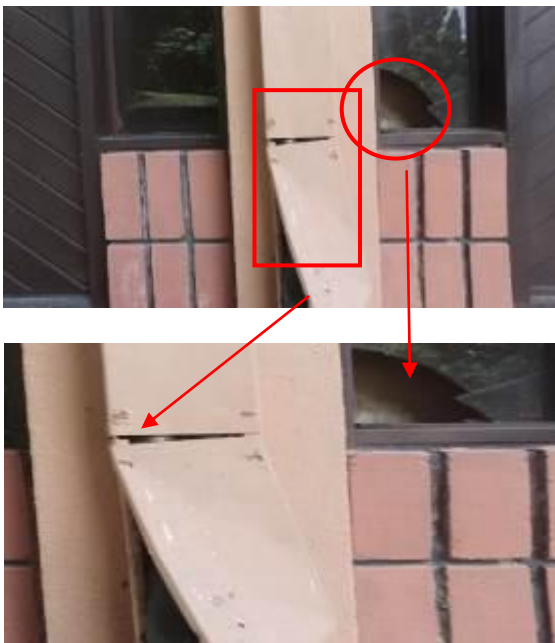
Image 16

Condition	Priority	Matrix	Colour
2	3	6	YELLOW

Element / components : Glass wall and wire box
Description of Defects : crack
Suggestion :
 Replace the glass with the new one and make sure the wire's box in good condition.

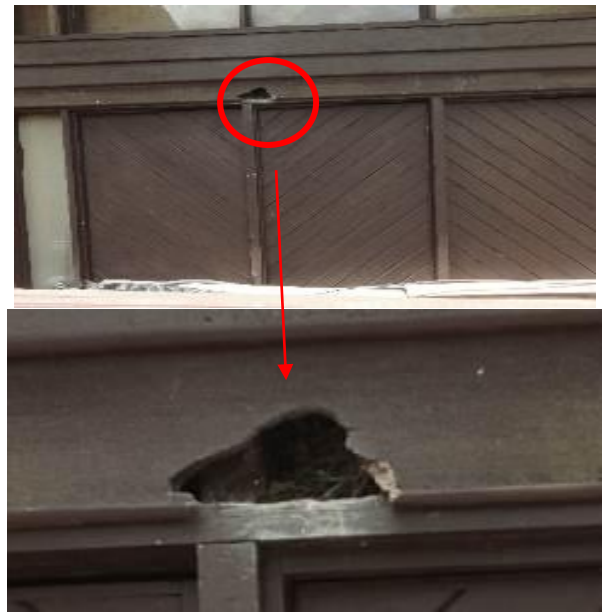
Image 13

Condition	Priority	Matrix	Colour
2	3	6	YELLOW

Element / components : Wall
Description of Defects :
 Perforated wall
Suggestion : repair the wall by replace the wooden wall
