Fracture Behavior of Carbon-Epoxy under Different Loading

J. V. Sai Prasanna Kumar

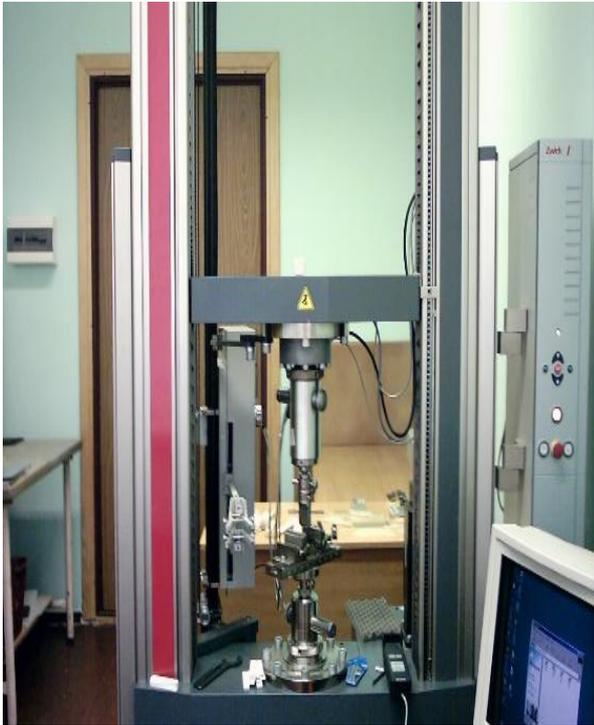
From the laminate the samples both DCB and ENF specimens were machined. Aluminum blocks were attached on the samples for DCB specimens which transfers load from the 100 KN loadcell to the specimen. These samples were mounted on the quasi-static Instron UTM figure 1. A total 10 samples were fabricated, a Teflon film of 40 μ was inserted in the mid-plane up to 40 mm in length.

Figure 1 DCB sample mounted in UTM

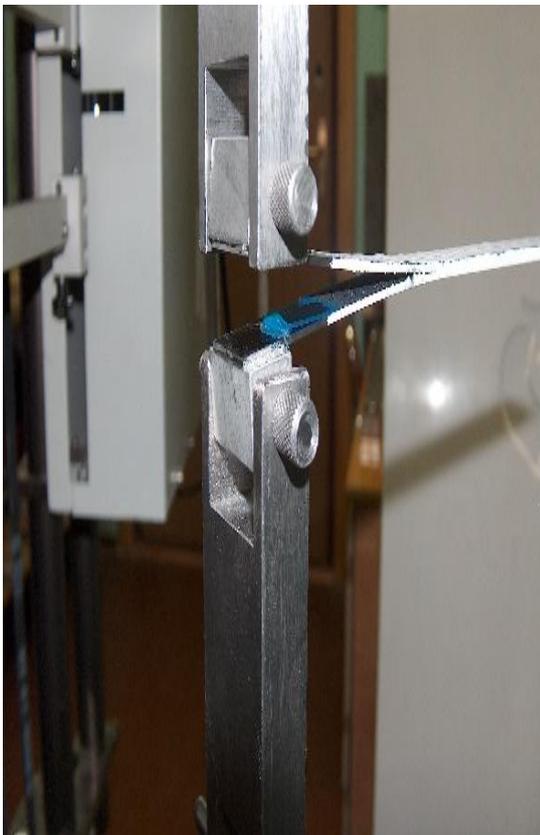
The length of the sample was 192 mm 3mm thick and 25 mm wide with a cross head speed of 5 mm/min figure 2.

Figure 2 DCB Testing in progress

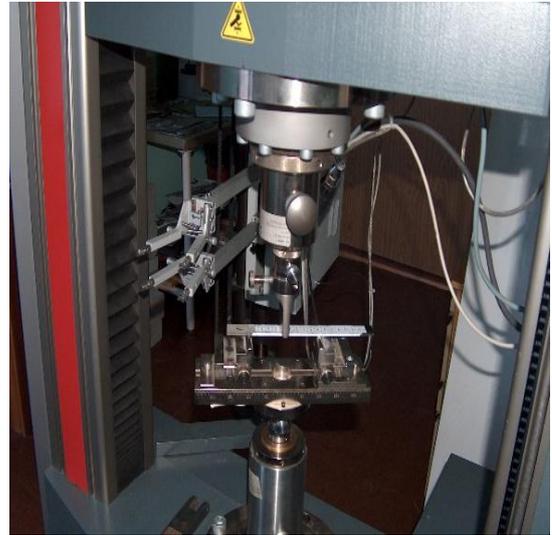
Out of the 10 samples and nine samples were tested. Seven samples in mode-II ENF samples were tested on three-point bending fixture with the quasi-static UTM at a crosshead speed of 2mm/ min at ambient atmospheric conditions figure 3

Figure 3 ENF Sample being tested

For ENF specimens the test conditions were the same as that of DCB specimens except the cross had speed was 2 mm /min figure 3.

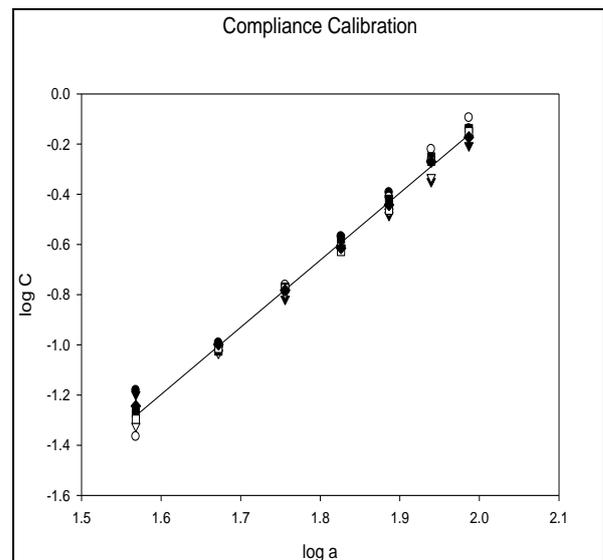
Nine DCB samples of different crack lengths were tested. The compliance was obtained from beam theory linear approximations were used to estimate the parameter from the slope of the compliance plot on logarithmic scale figure 4 and the value of n was 2.69. While the modulus was extracted from beam theory employing the experimental data for nine specimens and it was found to be 140389.3N/mm^2 and the moduli were $E_1^t=176\text{ GPa}$ and $E_1^c=143\text{ GPa}$ while flexure modulus $E_1^f=140\text{ GPa}$.

Figure 4 Compliance Calibration curve

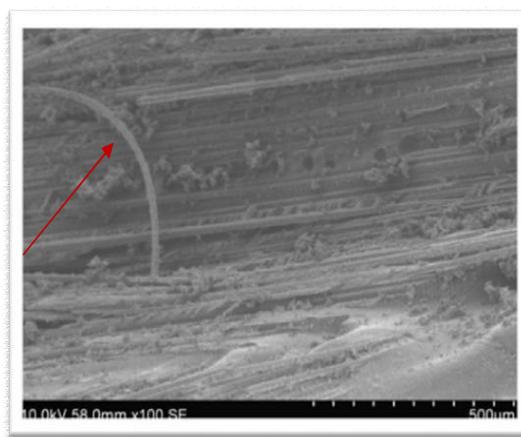
Figure 5 Mode-I fracture surface appearance represents a typical epoxy system with a ribbon indicated by an arrow

This typical failure characteristic of Mode-I delamination. It can be observed that a ribbon formed because of the interactions of the fast and slow side of crack propagation.

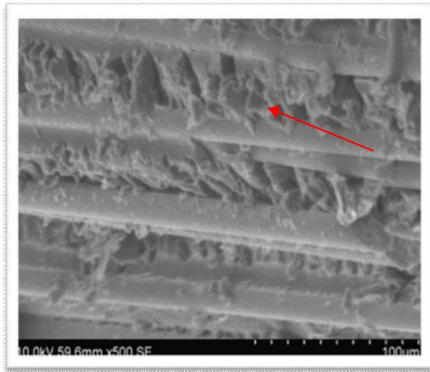
Figure 6 Mode I Fracture Surface Cusp Formation

Mode –I failure with a cusp formation which is typical of this mode. No distinction can be made between the fracture surface of the broken samples under very low and high crack opening velocities. The surfaces show carbon fibers with brittle broken epoxy matrix regions between them. Details of fracture sites include the ribbons can be seen and in addition one finds broken fiber ends; partly separated fiber bundles and pieces of broken matrix or fibers which remained somehow attached to the fracture surface Figure 7.

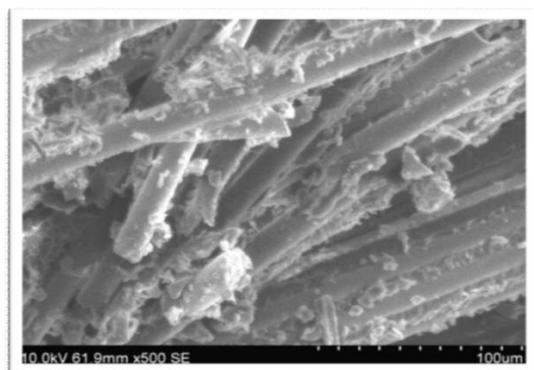
Figure 7 Fiber bundles and broken matrix

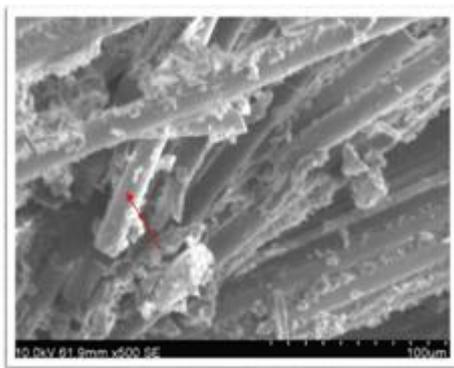
The existence of numerous pieces of broken matrix under shear type of loading could be shown in figure 8. Much bigger chunks of the matrix material seem to dominate the fracture surface of the broken sample and this may be an indication of a larger extension of the damage region around the propagating crack.

Figure 8 Mode-II fracture surface with broken fiber indicated by arrow

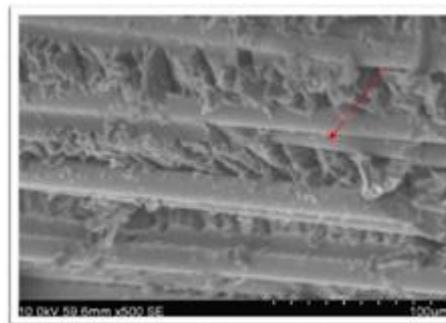
Figure 9 shows the typical failure of the ENF samples while testing under Mode-II. It can be observed that the fracture surface has a shear cusp formation which is the characteristic failure under Mode-II loading.

Figure 9 Mode-II fracture surface with shear cusp indicated by arrow
