# Influence of Mx-Trivex, A-Skew, Three Flat Threaded and Concave Shouldered Mx-Triflute Tool Pin Profiles on Tensile Properties and Fractural Behaviour of AA 6082-T6 Weldments during Friction Stir Welding

**Abstract:** Friction Stir Welding (FSW) is a topical and propitious solid-state joining process producing economical and strengthened joints of age-hardened and heat-treatable Aluminium Alloy AA 6082-T6. Mechanical and fractural behaviour of weldments were investigated in order to find crack initiation and necking on the weld zone thereby perceiving the complete behaviour of fracture occurred near the weld zone. Weldments are fabricated by employing four tool pin profiles namely MX-TRIVEX, A-SKEW, Three flat threaded and Concave shouldered MX-TRIFLUTE tools at various rotational speeds 1000 rpm, 1200 rpm and 1400 rpm at single traverse speed 25 mm/min. EXCETEX-EX-40 CNC wire cut EDM with 0.25 mm brass wire diameter has been employed to perform the extraction of tensile test specimens from the weldments according to ASTM E8M-04 standard. Tensile test was performed on electro-mechanically servo controlled TUE-C-200 (UTM machine) according to ASTM B557-16 standards Maximum Ultima

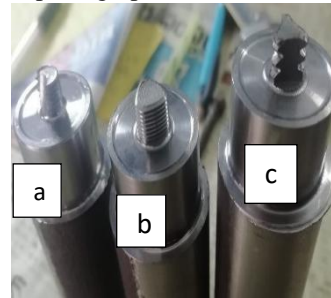
Fig. 4 (a), (b), (c) shows the photographs of A-SKEW, MX-TRIVEX and Three flat threaded tools. Fig. 5 shows the photograph of concave shouldered MX-TRIFLUTE.

**Fig. 4 (a) A-SKEW**

**4 (b) MX-TRIVEX**

**4 (c) Three flat threaded**

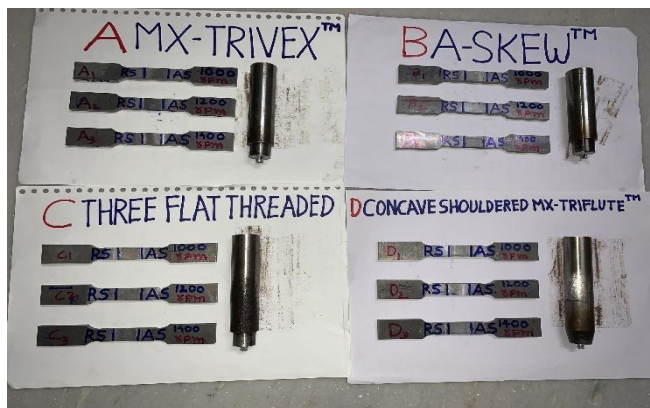
The tensile test specimens of MX-TRIVEX™, A-SKEW™ Three flat threaded and Concave shouldered MX-TRIFLUTE™ before performing mechanical test are shown in Fig. 12.

Fig. 12 Tensile test specimens of tool pin profile before performing mechanical test

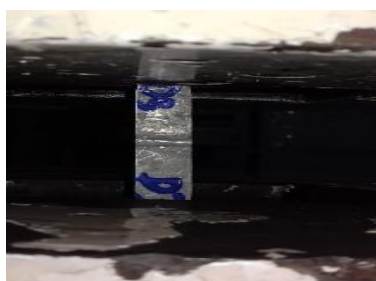
As per ASTM B557-16 standards, tensile test was performed on electro-mechanically controlled universal testing machine (UTM) at 150 kN (TUE make; C – SERVO - 200) as shown in Fig. 13. Gripping of tensile specimen in to the jaws is shown in Fig. 14.

Fig. 14 Gripping of tensile into the jaws

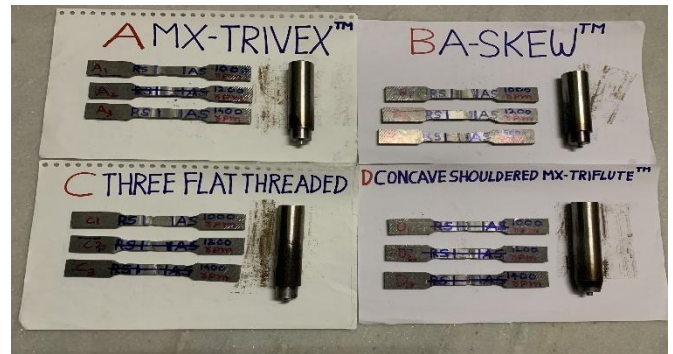
The tensile test specimens after performing mechanical test are shown in Fig. 15 (a) and location of shear occurred on tensile specimen is shown in Fig. 15 (b) respectively.

Fig. 15 (a) Tensile test specimens after performing tensile test
