# Effects on Reinforced Concrete Slabs by Environmental Loads

Aurora Martínez Loaiza, María Teresa Sánchez Medrano

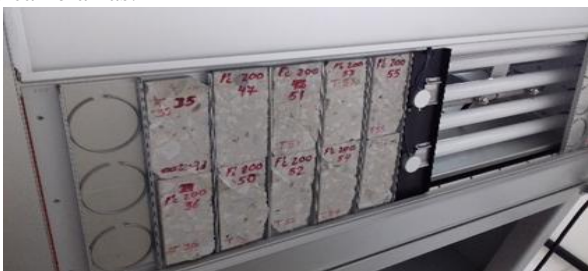
**Figure 2 Placing specimens in the EEA chamber. Source: Photograph of the authors**

In each type of concrete produced, the compressive strength in cylinders 150 mm in diameter and 300 mm high was determined, and the rupture module was calculated in beams 600 mm long, 150 mm wide, and 150 mm high tested to bending. For the accelerated aging test, 36 specimens (tablets) with average dimensions of 75 mm thick, 10 mm wide, and 150 mm long obtained from the cutting of concrete beams used in bending tests were used. For the cutting, a universal disk cutting machine brand Controls model 55-C0210 / BZ was used. 18 tablets with  $f_c = 20$  MPa and 18 tablets with  $f_c = 25$  MPa were placed in a QUV / spray model accelerated aging test chamber, distributed in such way that the end panels where less UV rays are received remain free, according to manufacturer recommendations. Figure 2 shows the arrangement of specimens in one of the four sections that the camera has.

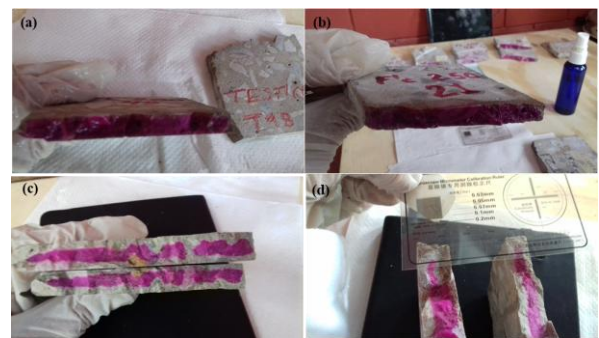
**Figure 4 Test to determine the carbonation front with phenolphthalein. (a) Tablet  $f'c = 200 \text{ kg / cm}^2$  of Control. (b) Tablet  $f'c = 250 \text{ kg / cm}^2$  of Control. (c) Tablet  $f'c = 200 \text{ kg / cm}^2$  with 180 hours in EAA. (d) Tablet  $f'c = 250 \text{ kg / cm}^2$  with 180 hours in EAA. Source: Photograph of the authors.**

Figure 4 shows the surfaces sprayed with phenolphthalein, where the control specimens for each type of concrete show the bright pink color, and the tablets tested in the artificial aging chamber show progress in the carbonation front. The changes in hue due to carbonation and uniform carbonation sections in most cases, are greatly appreciated. In other cases, such as the one presented in Figure 4c, it may be noted that some tablets showed complete carbonation throughout the cross section, although on the surface, they presented carbonation uniformity. This may be due to the porosity changes that are possible during the setting of concrete samples (Suárez-Domínguez, E.J. et al. 2020) that can modify the passage of liquids through the solid medium.

Regarding the carbonation potential, it could be observed that in all the tablets exposed in the accelerated aging chamber for both types of concrete there was a decrease in pH, the capillary interconnection existing in the pores of the concrete, as well as changes in humidity and high temperatures may be factors that decrease the resistance to penetration of the carbonation front.
