Tank Rehabilitation in Chennai Peri-Urban Area

Saravanan S. P., Gobinath R., Rajesh J., G. Sahithi, Neduri Prabhanjan, Sandela Haripriya

Abstract: Urban cities rely on surface water resources such as lakes, rivers for their survival, anthropogenic activities, rapid urbanization and industrialization had put thrust on such water bodies in major cities across India. Bountiful research works conducted also proves that such resources are rapidly depleting, and it also conveys that very few reasons contribute to major deterioration of lakes. Two major parameters that contribute to this deterioration include discharge of sewage into the water bodies and unplanned encroachments along the banks. This study aimed as a sustainable water resource management technique to rehabilitate a highly deteriorated tank in Kovilambakkam village, Peri-urban in Chennai city, India. The tank which is one of the primary sources of water for the area is affected highly due to urbanization and the natural ecosystem is disturbed. A best possible solution for rehabilitation is suggested using Socio-Economic method utilizing qualitative analysis like a PRA tools (Transect Walk, Focus group Discussion, Key Info

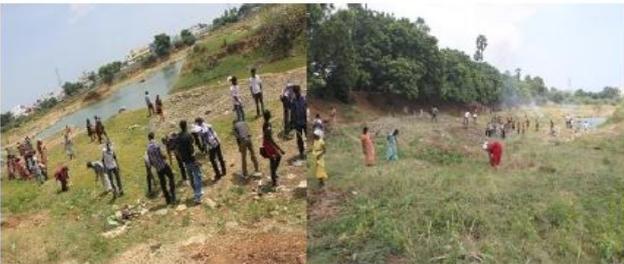
Figure: Workprogress of community people during the tank rehabilitation.

For the tank rehabilitation process, initially the NSS students were trained to undertake studies related to understanding the importance of sanitation, hygiene and the consequences of during contaminated water. Then were instructed to perform the cleaning operation of the tank systematically. This involved coordinating with local MREGS members and cleaning the tank. Simultaneously MREGS members were also trained to clean up the tank. Figure 7. Shows the work progress of community people during the tank rehabilitation.

With the successful coordination of all the tank was cleaned that enhanced the water storage capacity. Village people understood the importance of tanks and its uses. Tank is rehabilitated by removing the bushes from in and around the tank bund, debris inside the tank, cloth materials, plastic bags, covers, unwanted domestic wastages, vegetation's in and around were removed from the tank.

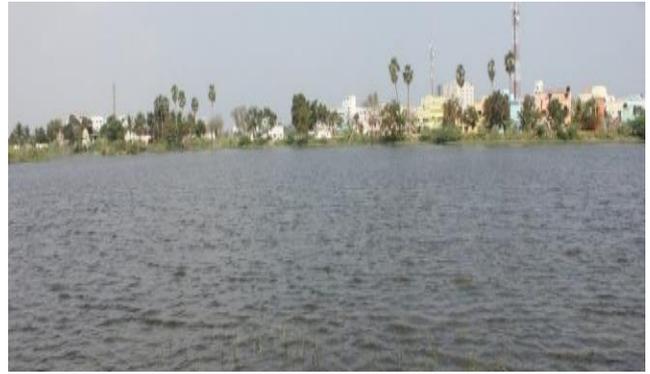
Figure 8. After tank rehabilitation.

Drainage inlet points were obstructed to entering into the tank. Finally left the tank free from all contamination of biological and physical components, so it led to storing large capacity of water in the tank. It greatly influenced the maximum recharging capacity of ground water from the tank bed, it also induced the rise of water table in that area during pre and post – monsoons. Figure 8. shows the after the tank rehabilitation. Above all now there is an increasing commitment and realization found among the community members to safe guard their water resources for resolving their drinking water problem.
