# Sub-Surface Flaw Detection of GFRP Components Using Non-Destructive Methods

**Abstract:** *Non-destructive testing enables a way to identify and evaluate the surface as well as sub-surface defects of materials, without altering the structural integrity. This paper concentrates the experimental demonstration on few of the non-destructive techniques. Based on the test results the nature & properties of the defects are discussed in comparison with base material. The glass/epoxy laminates are prepared in the form of pipes & laminates in which artificial defects are introduced by inserts & milled holes. By testing these defective specimens through various methods like ultrasonic testing, radiography testing, thermography testing the defects are identified and hence the properties of the defects are discussed.*

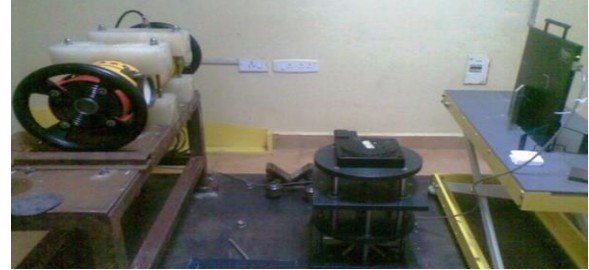
**Fig. 3** X-Ray Radiography test setup

In the Digital radiography testing shown in Fig. 3, the specimen is fitted in rotary module and aligned as required by the controller. The amount of x-rays emitted is controlled by the application of electrical voltage. Amorphous Silicon panel with Cesium-Iodide is used as the detector which converts the falling x-ray density to corresponding voltage which could be analyzed through the software.

The specimens with known artificial defects are tested under controlled x-ray exposure with the application of electrical input to x-ray emitter. The range of the inputs is 85-95kV & 0.8-1.2mA for the duration of 1-3seconds.

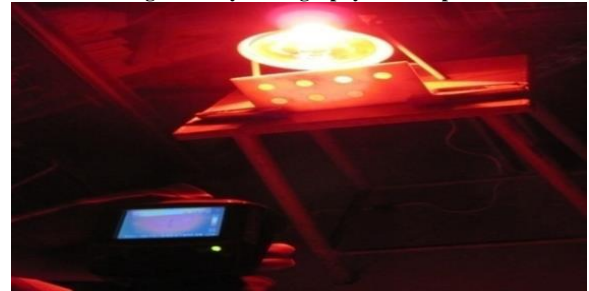
**Fig. 4** Thermography test setup

The thermography test shown in Fig. 4, has been done by taking 150W IR lamp for the milled test specimens and 1000W halogen lamp for the specimens with the aluminium, Teflon inserts as the thermal energy source.

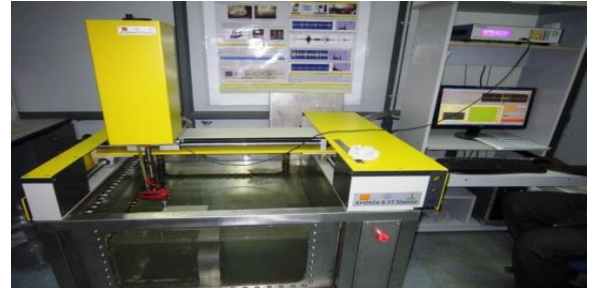
**Fig. 5** Thermography test setup

In the ultrasonic testing shown in Fig 5, the specimen is fitted inside the mechanical module contains the coupler typically water to avoid the mismatch of air and specimen. The transducer holder is connected to controller to move it in x and y directions. The transducer is a computer controlled pulse transmitter/receiver. The transceiver analyzes the reception of ultrasonic signals in compare with transmitted and generates the information as A, B & C scan images.

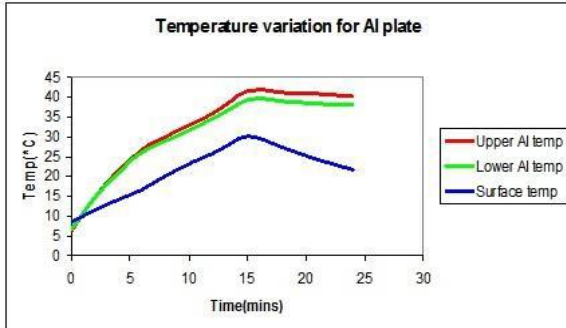
Fig. 12 Temperature variation at interest point of laminate with aluminium inserts

From the Fig. 11, it can be analyzed that the area of the insert is brighter since the defect absorbs more heat and from the graph shown in Fig. 12, the insert retain the heat for a longer time ever after the removal of the heat source hence it would be a metal. The upper curve in the Fig. 12 shows higher temperature than the lower hence it shows the upper curve denotes the insert which closer to the heat source.

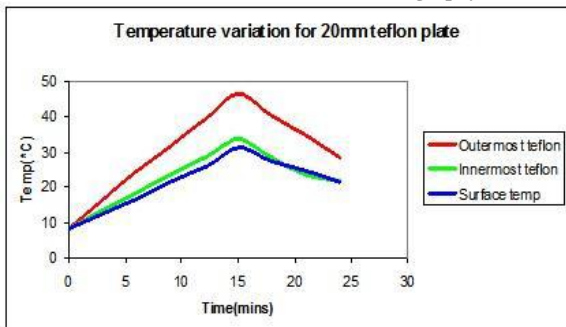
Fig. 14 Temperature variation at interest point of laminate with 10\*10\*1mm³ teflon inserts

The Teflon at the upper layers appears more clearly in the thermal image shown in Fig. 13 than the teflons at the lower layer due to the distance from the heat source. Even also there is some notable difference for the teflons at the lower layer than the surface due the variation of thermal properties between that. The decrement in the all these curves shown in Fig. 14 after peak says the defect is either a gap or some other material with moreover similar properties like the surface and it is evident from the curves of surface temperature & innermost Teflon temperature.

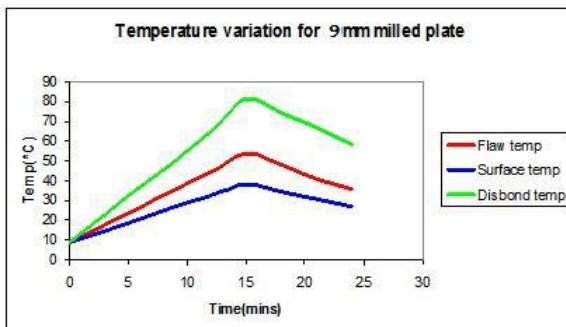
Fig. 16 Temperature variation at interest point of pipe with 9mm milled holes

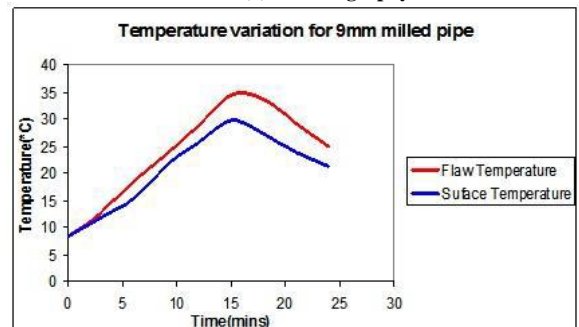
Fig. 20 Temperature variation at interest point of pipe with 9mm milled holes

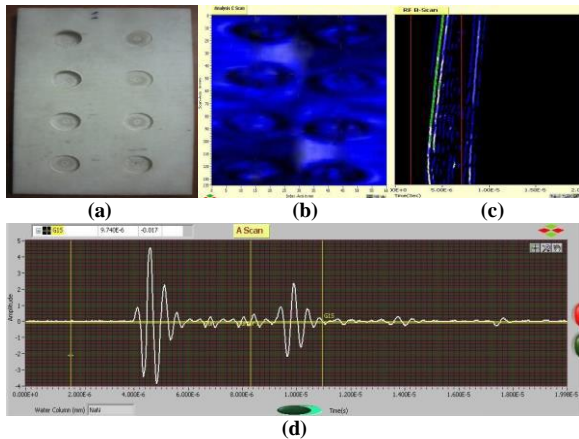
Fig. 27 Ultrasonic images of laminate with 9mm milled holes in the region without defect (a) Visual (b) C-Scan (c) B-Scan (d) A-Scan

The front wall also varies in this case unlike others due to the milled defects and this could be analyzed through the amplitude variation of A-scan image shown in Fig. 27(d) and Fig. 28(d).

The C-scan image given in Fig. 27(b) and 28(b) shows, the position of defects and also indicates the test points where the further processing to be done for the estimation of properties of the defects.

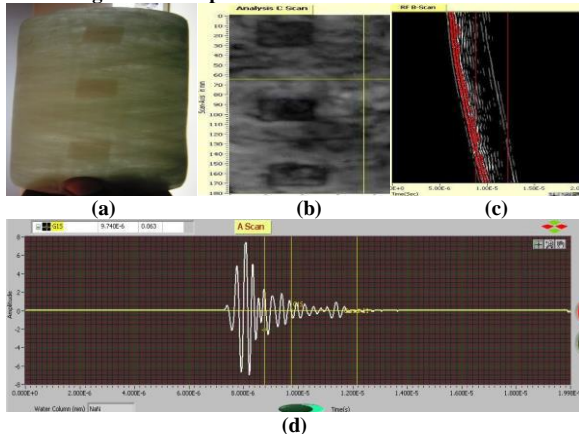
Fig. 30 Ultrasonic images of pipes with 10\*10\*1mm<sup>3</sup> teflon inserts in the region of without insert (a) Visual (b) C-Scan (c) B-Scan (d) A-Scan
