Robotic Model for Unmanned Crack and Corrosion Inspection

Peter Oyekola, Aezeden Mohamed, John Pumwa

To reduce the cost of inspection as well as downtime due to inspections and maintenance, deployments of mobile robots with fault tracking and identification purpose are steadily increasing. This paper, therefore, details the implementation of an image processing technique using MATLAB to identify defects of structural elements.

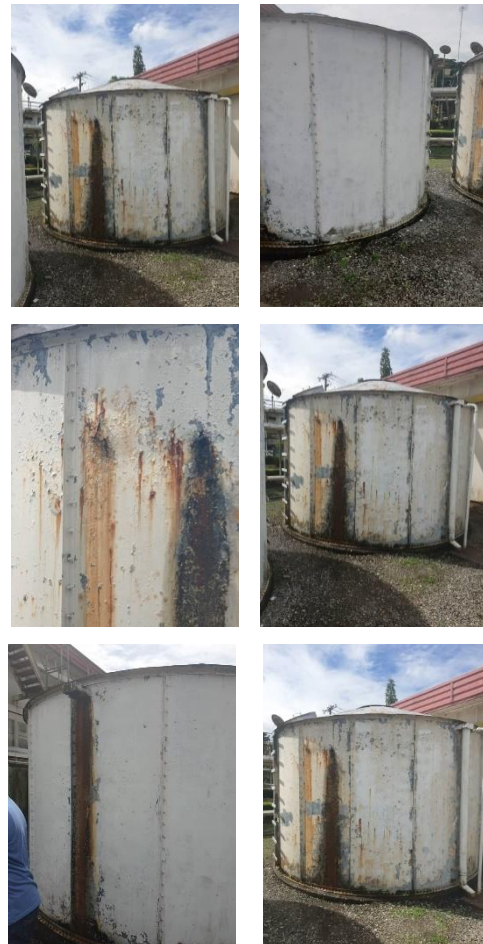
Fig. 1. Corroded storage tank surface

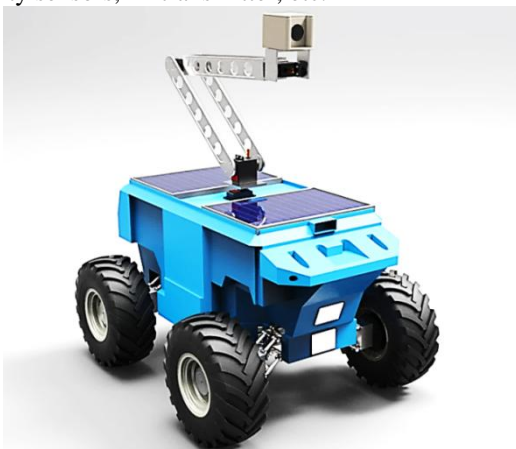
Fig. 3. Robot platform with wireless inspection camera

The project involved the initial construction of an unmanned vehicle designed to support and carry the necessary inspection equipment such as wireless cameras and sensors, then the electronic and mechanical control function of the vehicle was worked on. This included the integration of driving mechanism, tire selection, speed and power calculations, etc. the wireless control module was also installed to control all actuators on-board the vehicle. The final phase of construction involved testing vehicle mobility in real conditions. Hardware components involved DC motors, servos motors, batteries frame wireless video transmitter and receiver module, cameras, and a solar module for vehicle charging. Other peripheral sensors were also installed on the vehicle to aid in measuring other variables not mentioned in this paper, such as temperature and humidity sensors, IR transmitter, etc.

The UGV is equipped with a wireless camera that transmits images from within a 100m radius. This allows the vehicle to inspect the surrounding and transmit images for crack analysis. The images are conveyed over a wireless receiver, which is directly linked to a monitor.

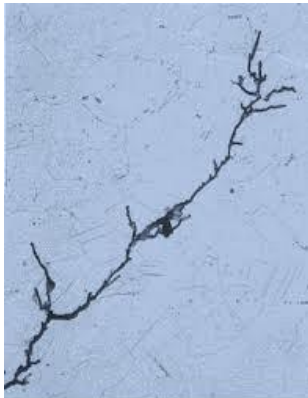
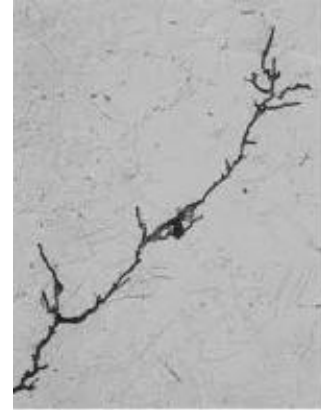
Fig. 6. Illustration of enhanced image: (a) Original image from mounted wireless camera and (b) image after application of non-linear filter

The non-linear method was employed in image filtering. This method considers the filtered (f^*), original ($f_{org}(i,j)$) and blurred ($f_{blur}(i,j)$) pictures of the defect as shown in the equation 1 below.

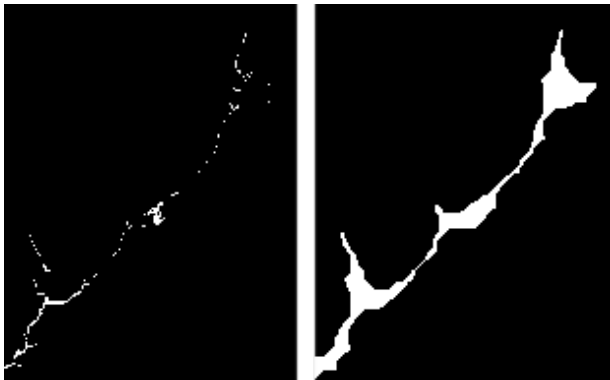
Fig. 7.(a) After threshold application (b) image after application of median filter

This step was done using the median filter technique to remove unwanted noise from the image to enable better analysis.

Windows were allocated in odd numbers and sorted numerically. Sometimes though, some parts of the cracks are removed after the application of the filter.

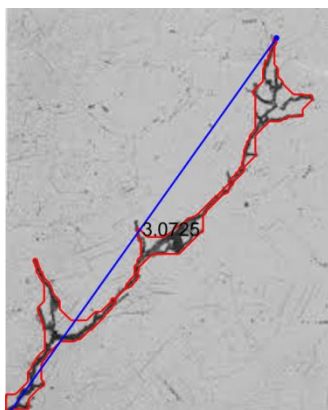
Fig. 8. Final output showing crack length

The classification of cracks was obtained using MATLAB, and a noise-free image is obtained after several layers of image processing. Several samples of cracks on different structural materials such as steels, super alloys, mild steels, and even cement were tested and analysed. The resulting output image showed an estimate of the crack length, which is obtained by specifying the approximate area of the original image. (See figure 8 below)
